Pre Purchase Building and Pest Inspection

Address:	1 Smith Rd
Day and Time Inspected:	Date: 16/7/2025 12:00pm
Weather and Temperature:	Degrees 22 Humidity 50%

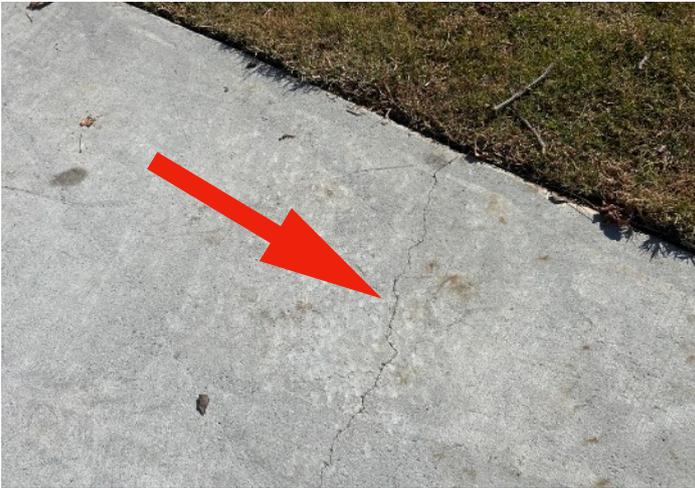
2

Condition of driveway was mostly good/average some hairline cracking was noted see comment on Concrete Cracking – Driveways, Paths and Carports in report below.

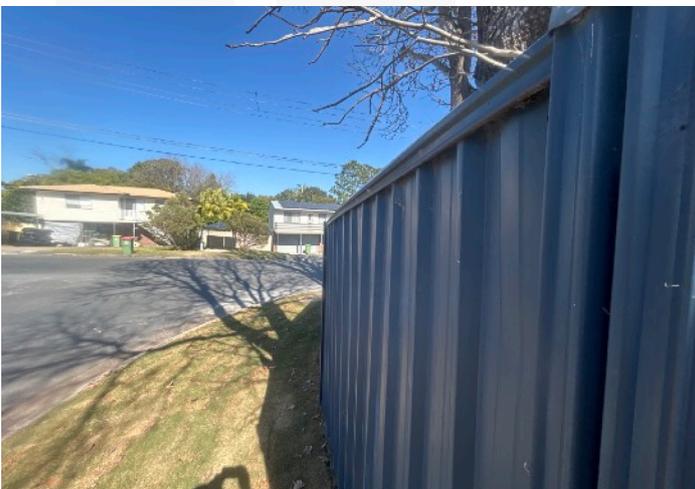
3

Condition of colour bond fencing was average/poor there is damage to sheets, top rails and post are leaning.

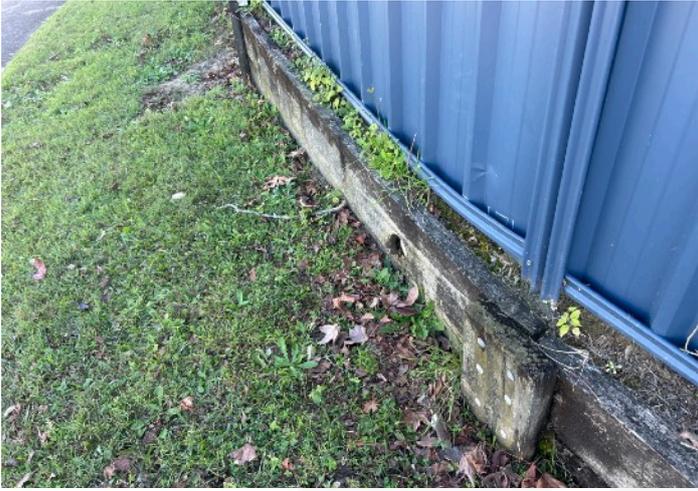
4

Condition of small timber retaining walls at boundary of property are in poor condition

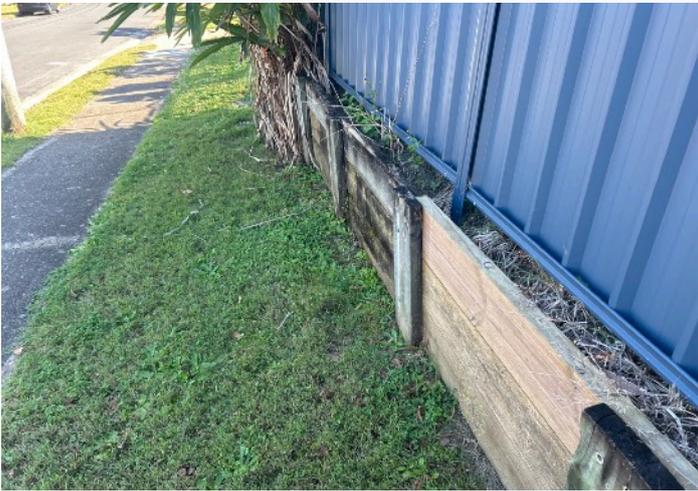
5

Some timber sleepers have been replaced, but overall condition of timber retaining is poor

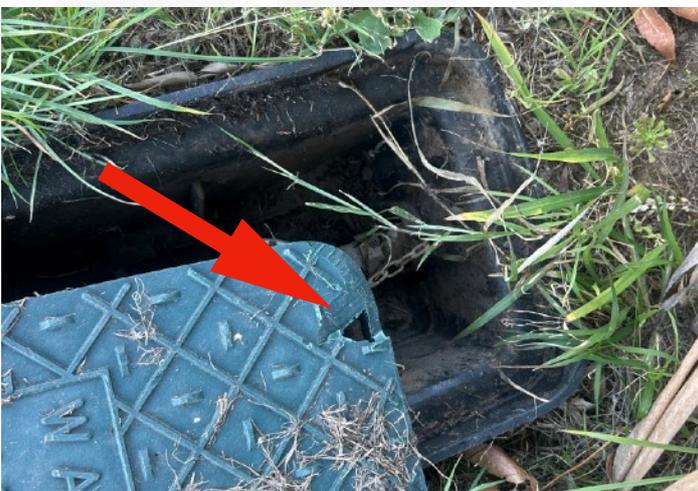
6

Plastic cover to water meter is damaged

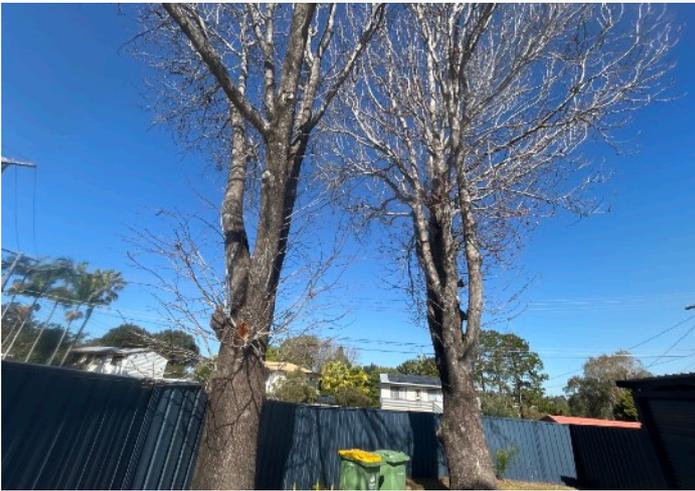
8

The property has two large trees in front garden. The root systems of large trees can crack/damage underground services, concrete paths and driveways area should be monitored for movement.

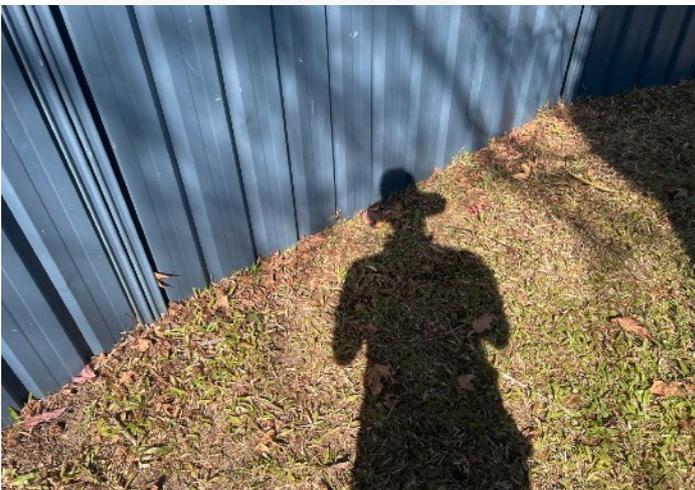
9

Soil has been built up at base of colour bond fencing. This can cause sheets to rust at base. Recommend lowering level of soft landscaping.

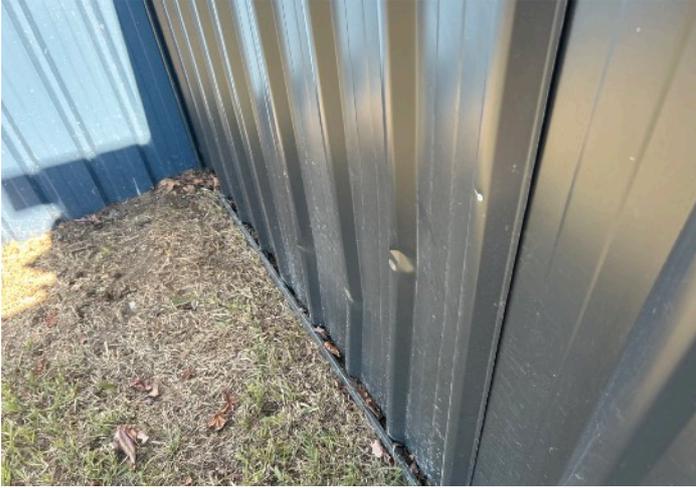
10

Damage noted to colour bond fencing around the property

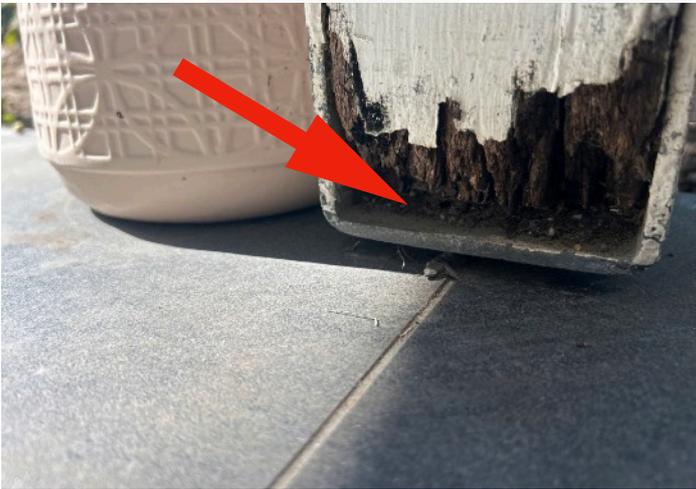
14

Base of timber post at front of property have degraded and require repair/maintenance. Trade recommendation Carpenter/Painter.

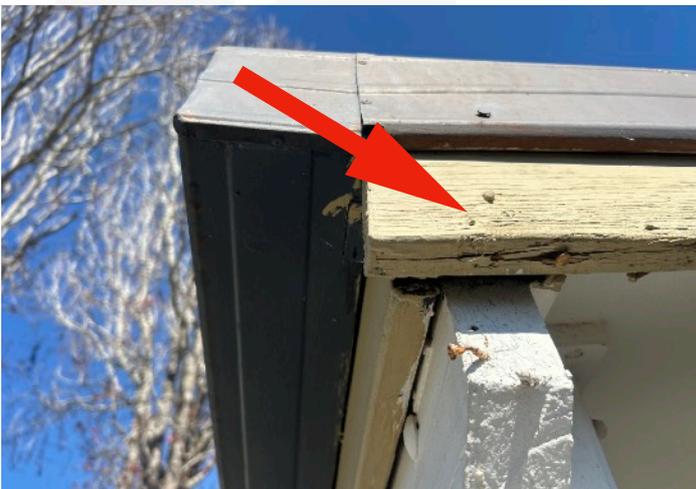
15

Fascia boards to the roof and eaves have areas of wet rot and decay and require rectification/repairs

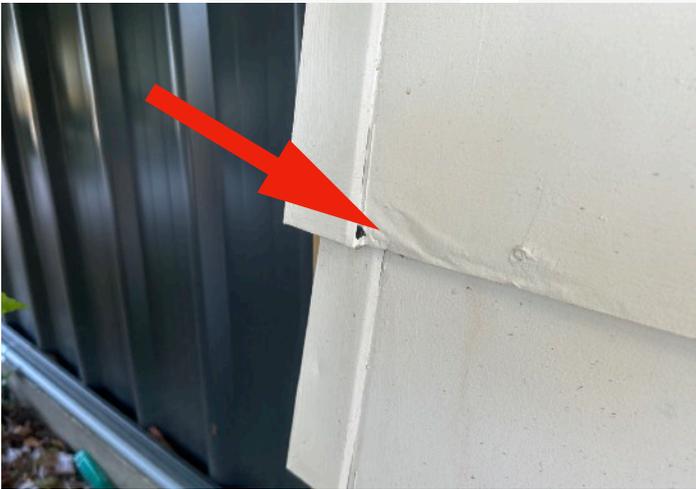
17

Areas of wet rot and termite activity were noted to the front left-hand corner of the property that should be investigated further by a licensed builder

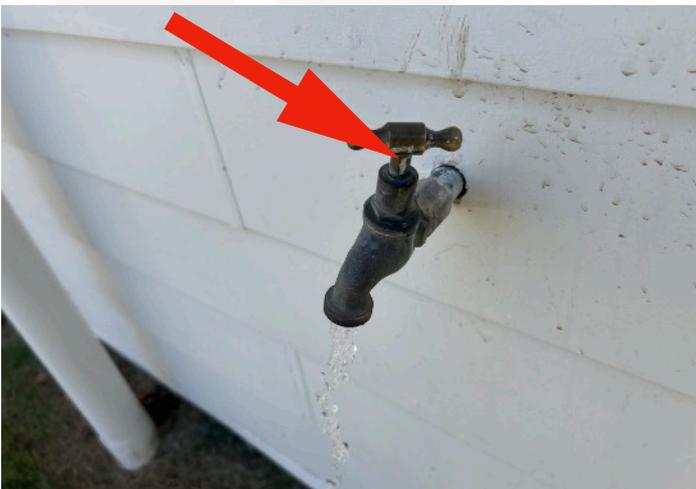
18

External tap at front of property requires maintenance leaks at top and penetration through wall has not been sealed correctly. Trade recommendation – Plumber.

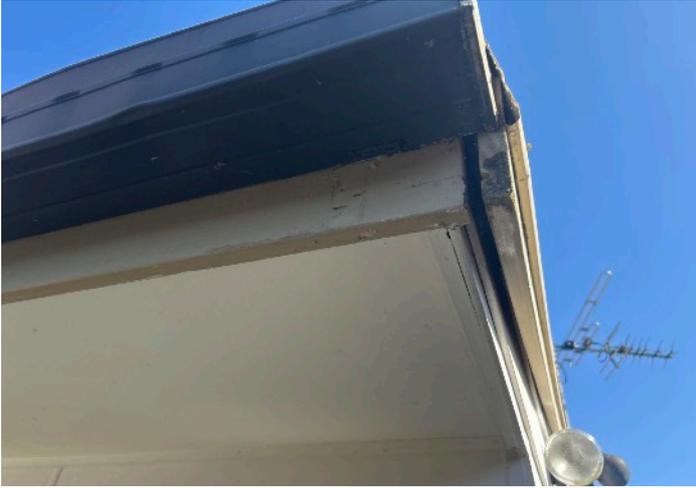
19

Fascia boards to the roof and eaves have areas of wet rot and decay and require rectification/repairs

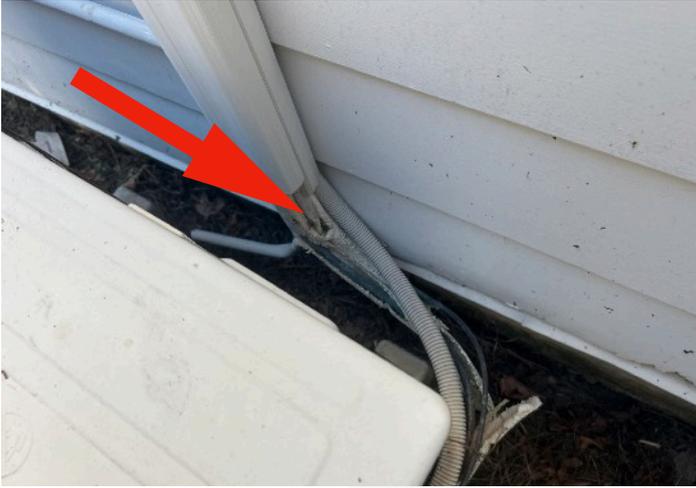
22

Servicing pipes to split Aircon require maintenance/repairs and have degraded

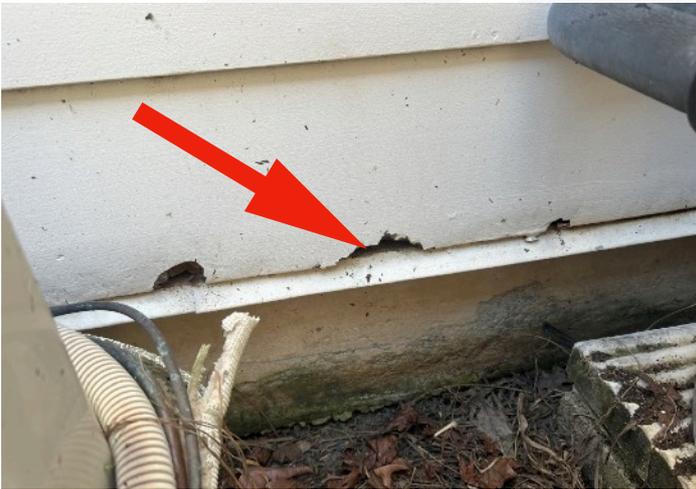
23

It appears there is wet rot/termite damage to the right hand boundary cladding at base requires further investigation - rectification/repairs

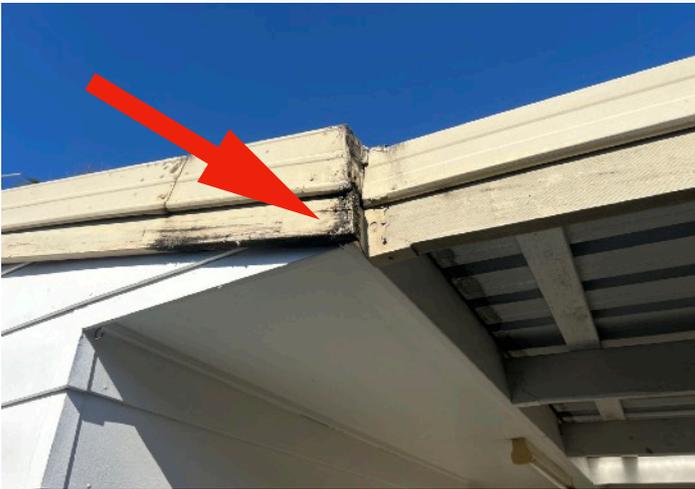
26

Fascia boards to the roof and eaves have areas of wet rot and decay and require rectification/repairs

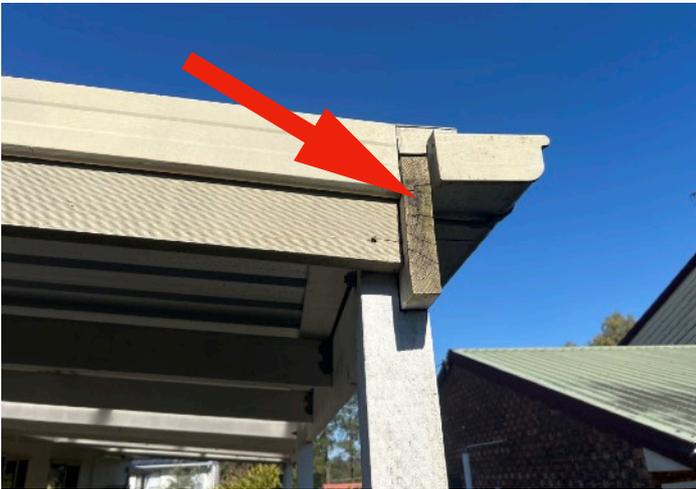
29

Recommend sealing end grain of patio roof beams to limit potential water ingress. Trade recommendation – Painter.

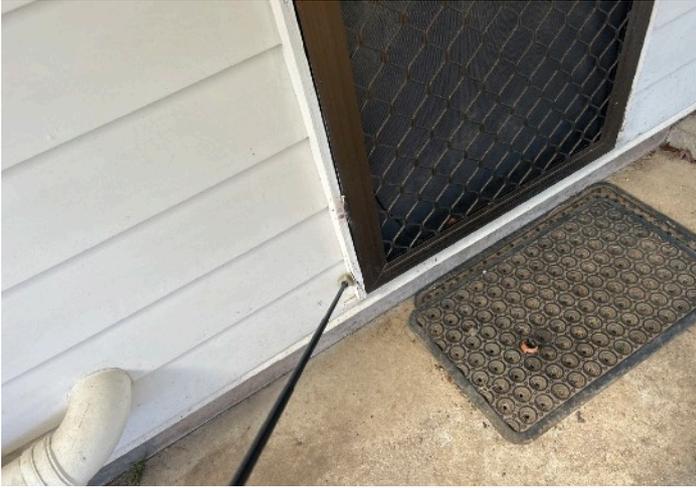
31

Trims to the laundry back door are damaged and require repairs. Trade recommendation – carpenter.

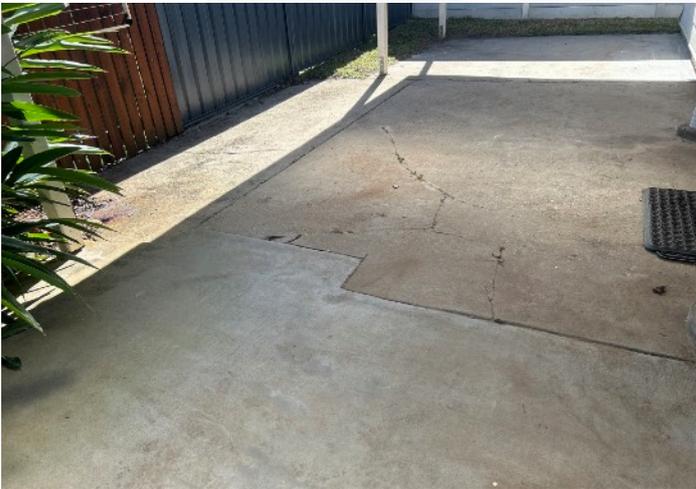
32

The condition of the rear patio concreting was average/poor there is multiple cracking to slabs. See note below on concrete cracking.

Recommendation: Monitor any cracking for signs of progression. If cracks are wide, uneven, or show signs of movement, consultation with a qualified concreter or structural engineer is recommended for further assessment and potential remediation.

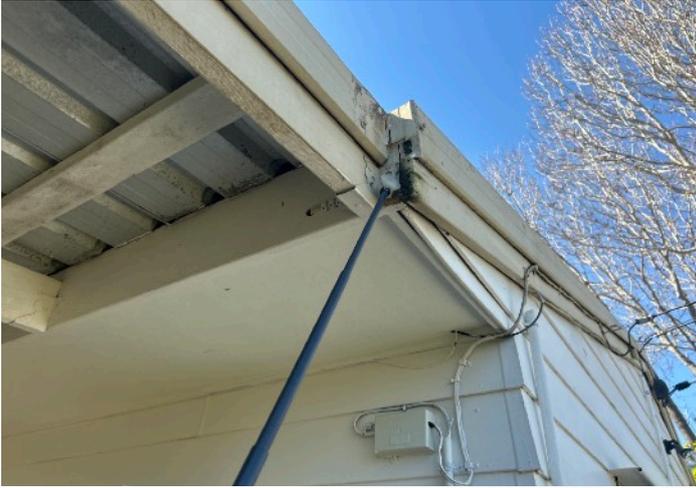
34

Fascia boards to the roof and eaves have areas of wet rot and decay and require rectification/repairs

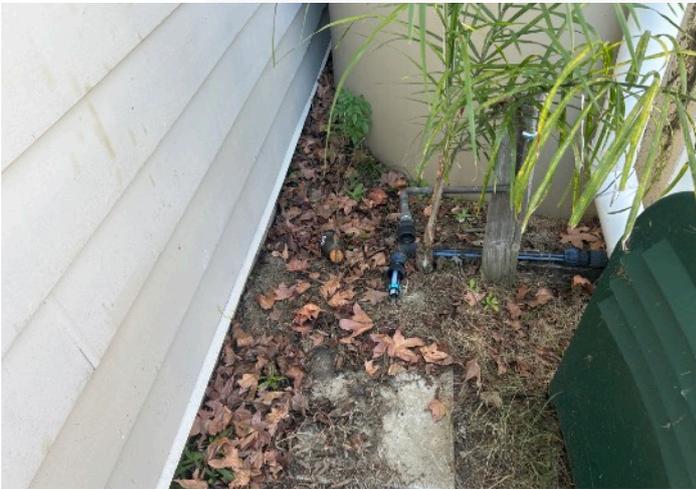
35

There was no pump for stormwater storage tank connected at the time of inspection

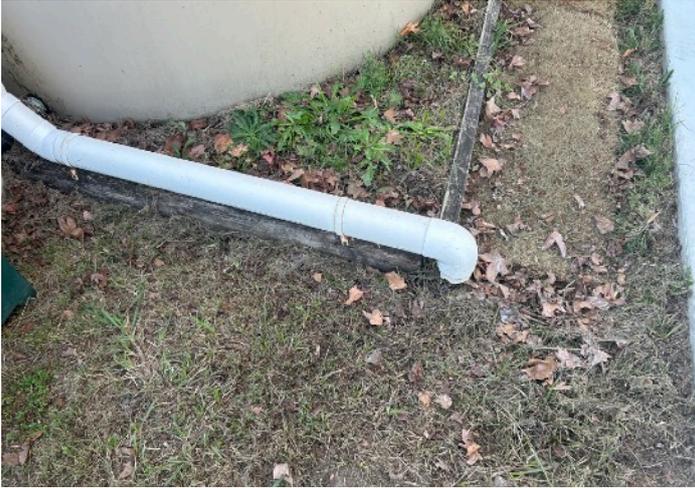
37

Water tank is not connected to stormwater and discharges on ground

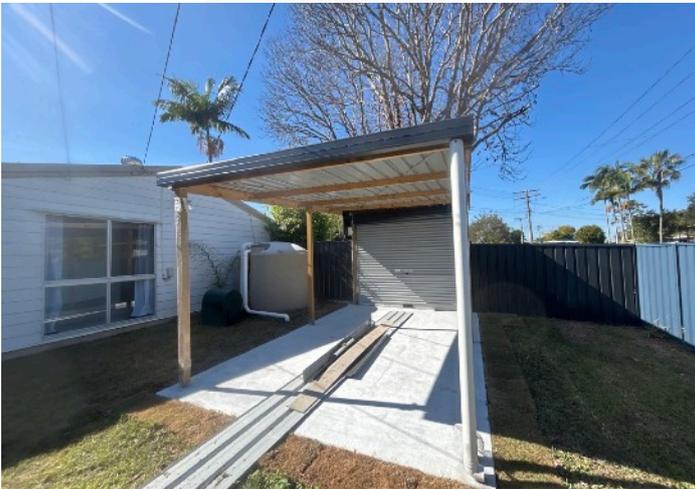
38

Carport structure has been constructed in an unconventional manner. Recommend ensuring this structure has council approval and has been engineered to an appropriate standard.

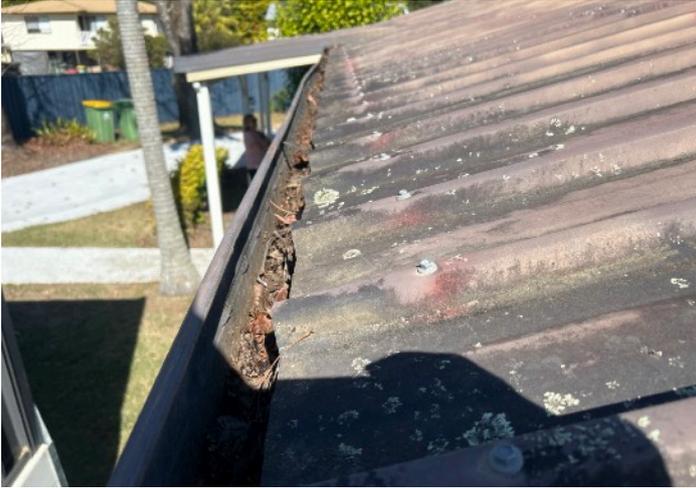
40

Areas of the roof guttering required debris to be removed

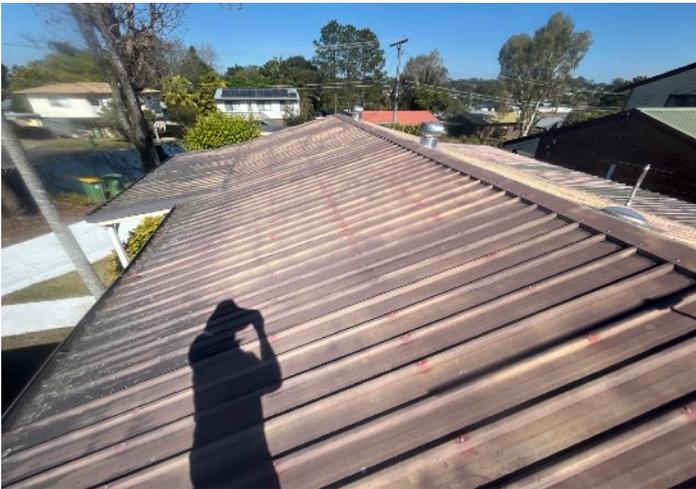
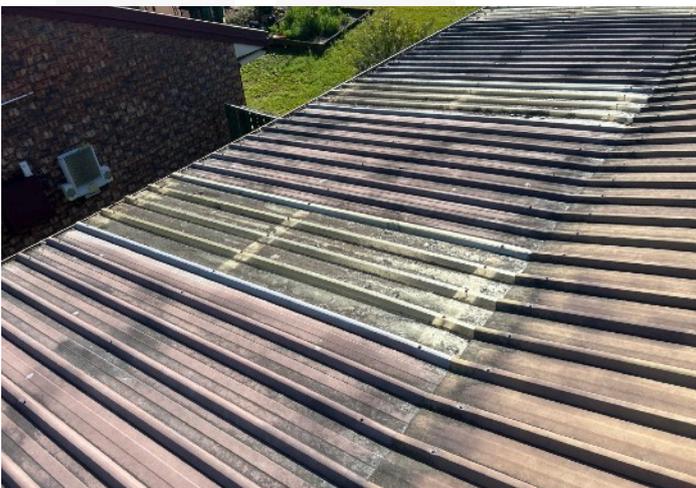
Overall condition of roof was average/poor

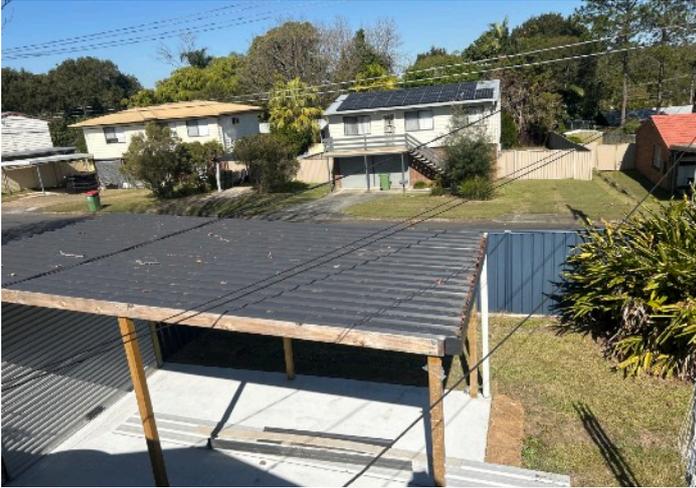
43

Gutters to the carport structure are filled and required debris to be removed

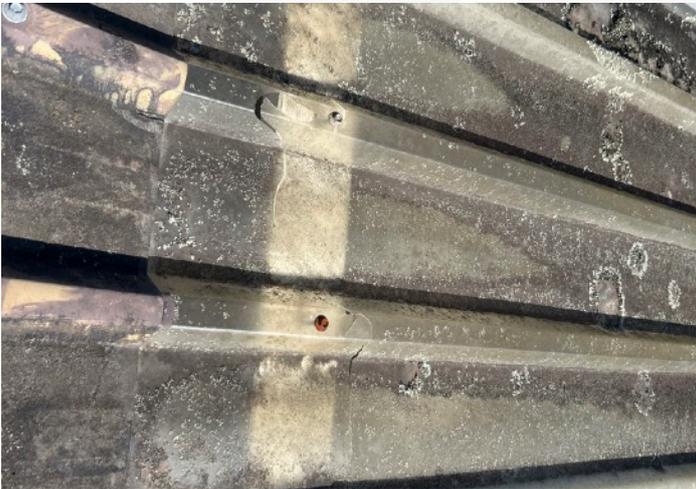
44

Transparent polycarbonate sheets on patio roof are damaged/ degrading and cracked and require replacement. Trade recommendation – Roofer.

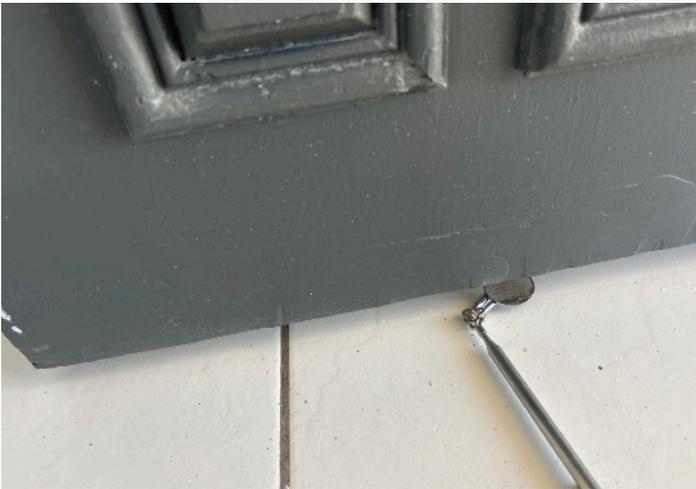
47

Condition of front door was average. Recommend sealing bottom edge of door to limit potential water ingress and swelling.

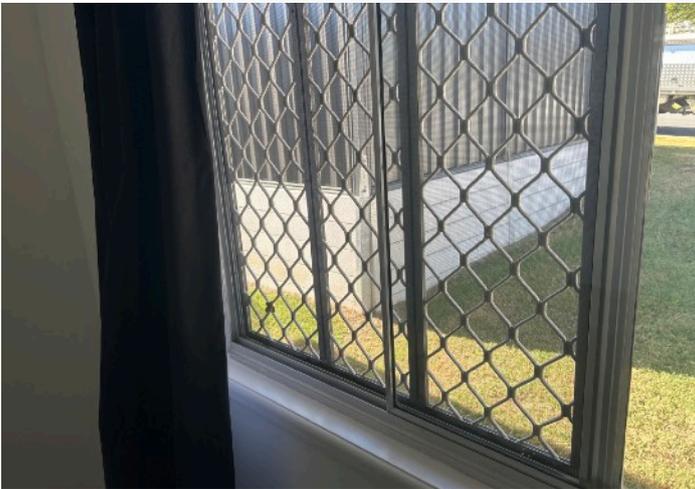
50

Widespread - Aluminium windows appear to be functional but would benefit from servicing of runners. Also, flyscreens are damaged to most windows and require replacement.

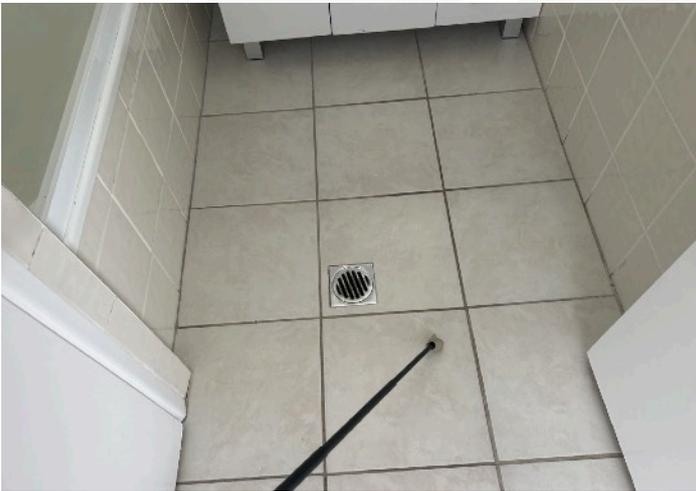
59

Floor tiles are drummy and appear to have been laid on top of old tiles.

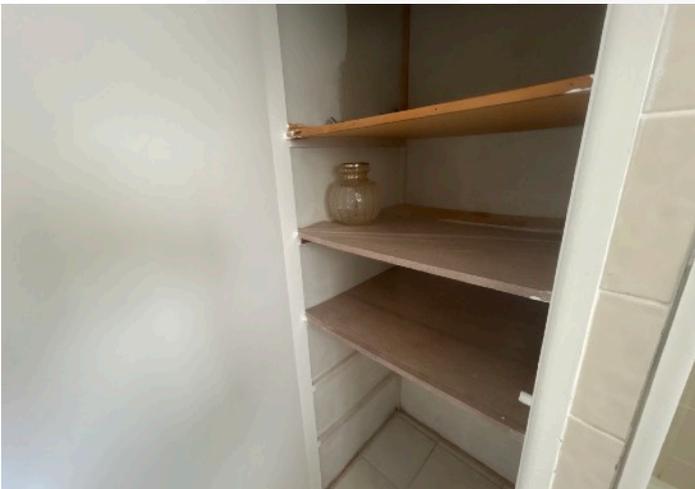
62

Cupboard in bathroom was in poor condition. Recommend replacing shelving trade recommendation – carpenter.

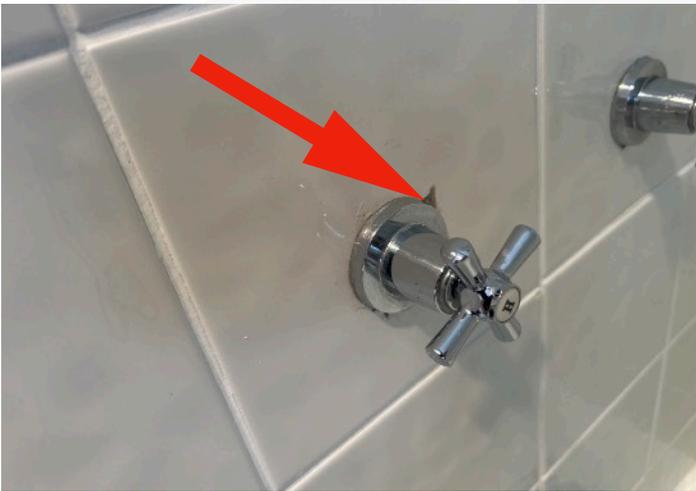
65

Damage to tiling behind tap was noted, an area where potential water could ingress into wall. Trade Recommendation - Plumber

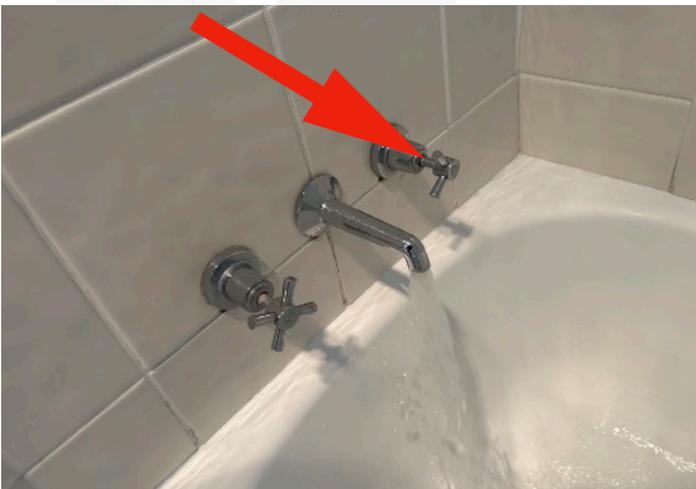
66

Bath spout functioned. Taps are damaged and require repair repairs. Trade recommendation – Plumber.

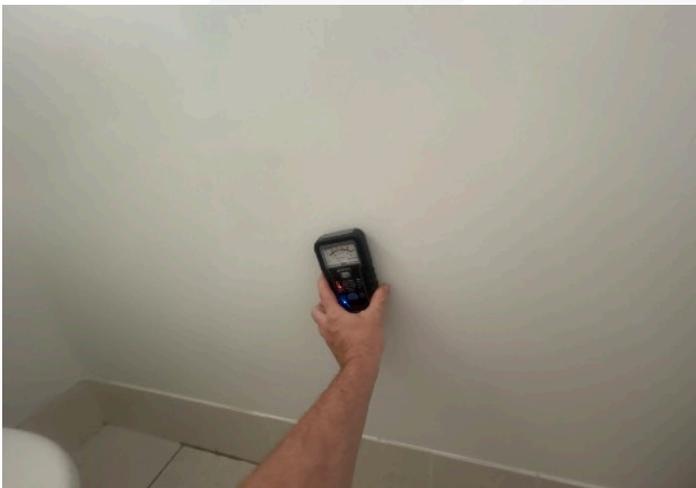
68

Moisture meter readings were taken behind wall surfaces of shower and at the time of inspection no high readings were found. Note showers had been vacant for some time. Meaning of potential leaks may not be picked up

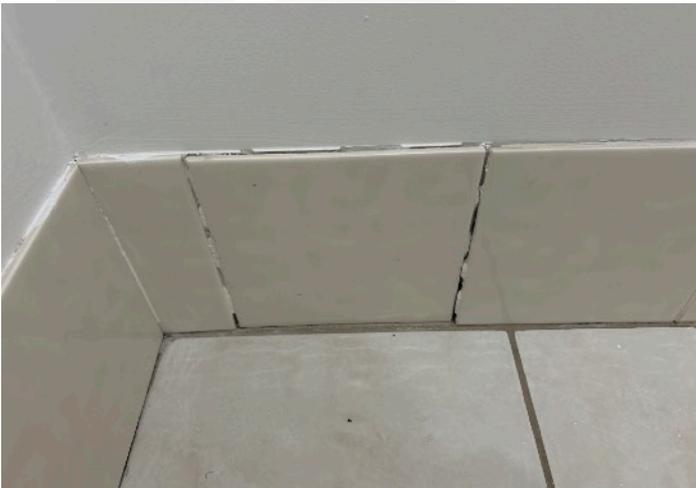
72

Tiling is damaged to toilet area. Trade recommendation – Tiler.

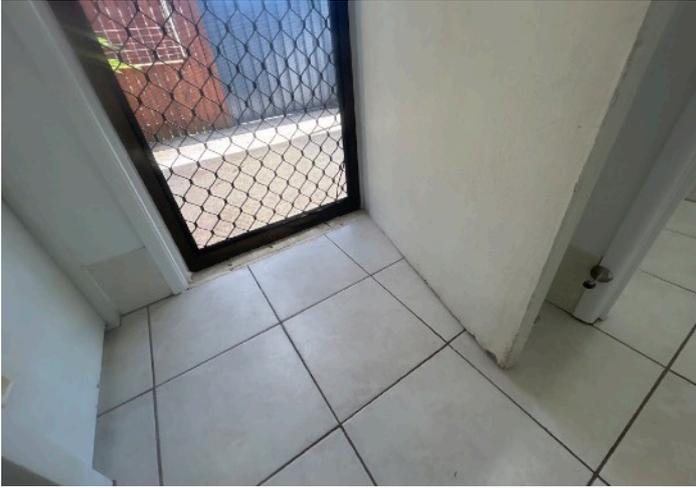
76

Laundry door is catching on tiles and has water damage to bottom of door. Recommend replacing with new door trade recommendation – carpenter.

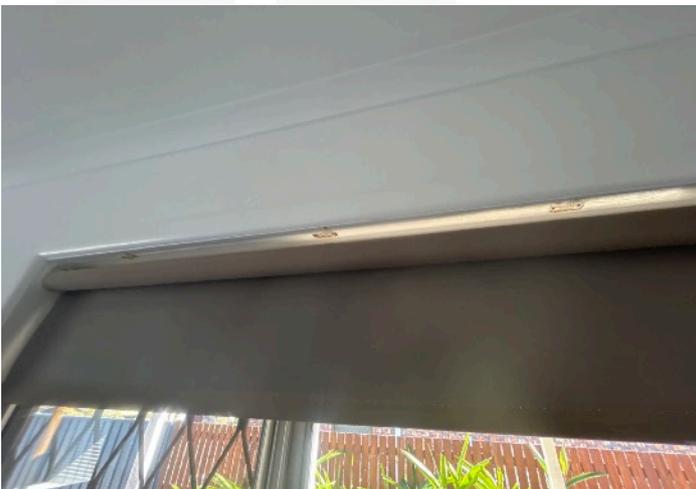
78

Paint patching required to kitchen window reveals. Trade recommendation – Painter.

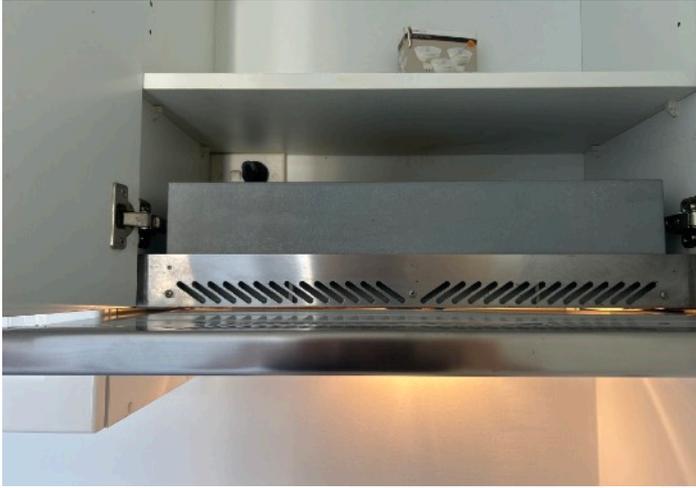
79

Rangehood was functioning at the time of inspection. Recommend venting Rangehood to external of property currently discharges into cabinet.

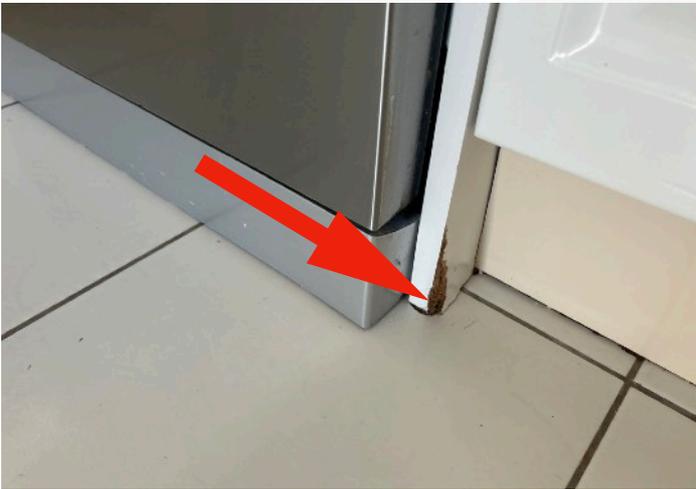
83

damage was noted to some of the cabinetry in the kitchen

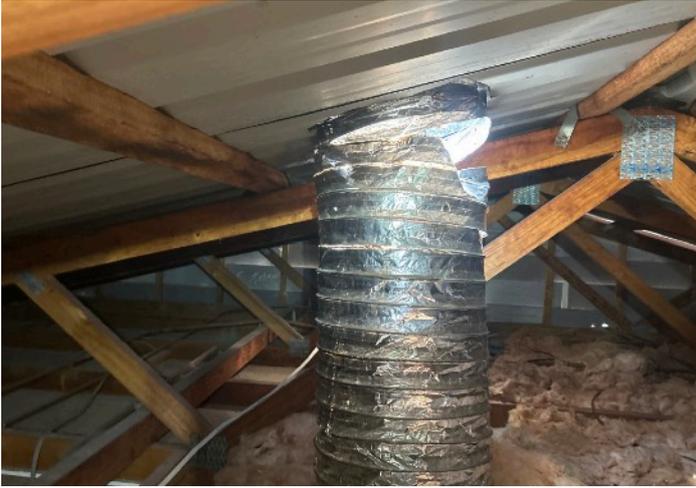
88

Skylight ducting is damaged and requires repairs

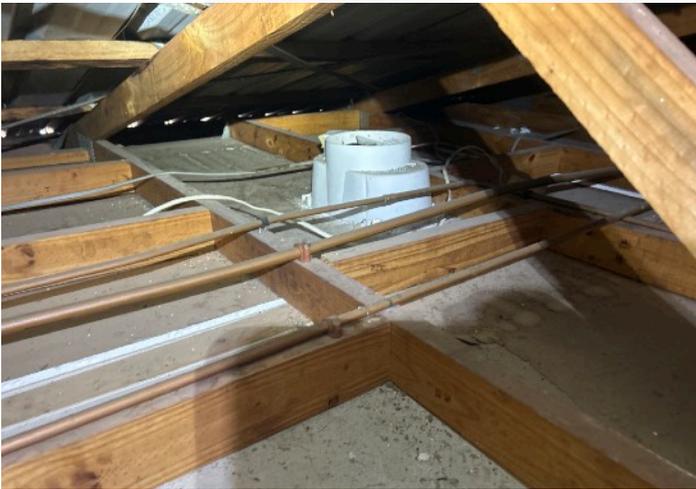
89

Recommend ducting bathroom fans to external of property

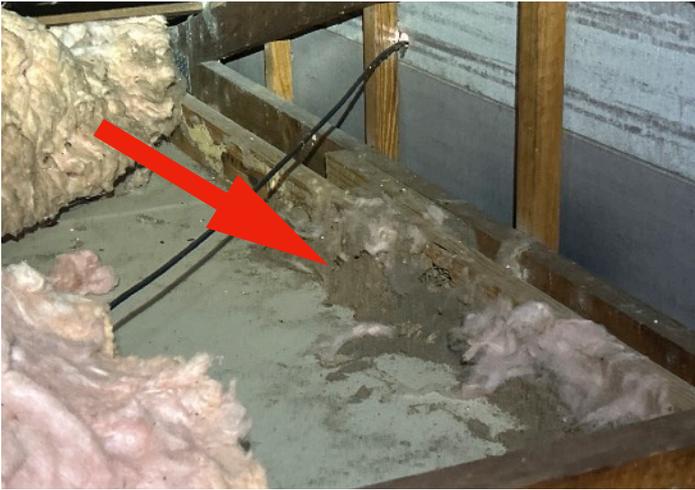
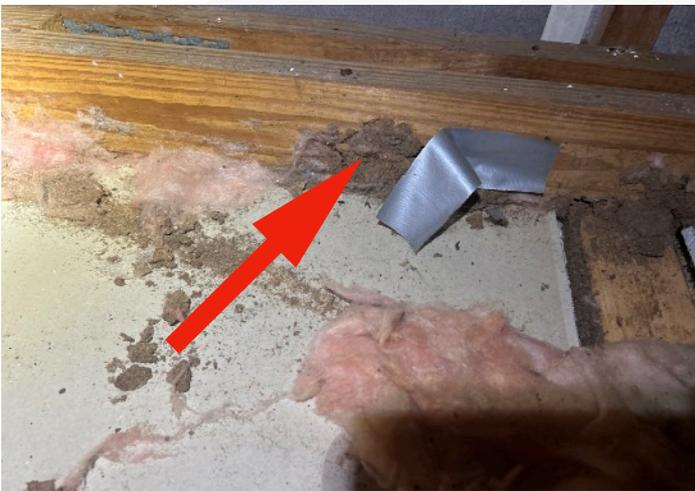
Termite workings have damaged the structure of the timber frame. Further invasive investigation is recommended to determine the extent of the damage. Damaged appears to be widespread.

- 1. This property compared to one of similar age and style of construction is considered Poor (x) Average () Good ()**
- 2. MAJOR DEFECT - Historic termite workings were found in the structure that need to be invasively inspected to determine the extent of the damage to the framework.**

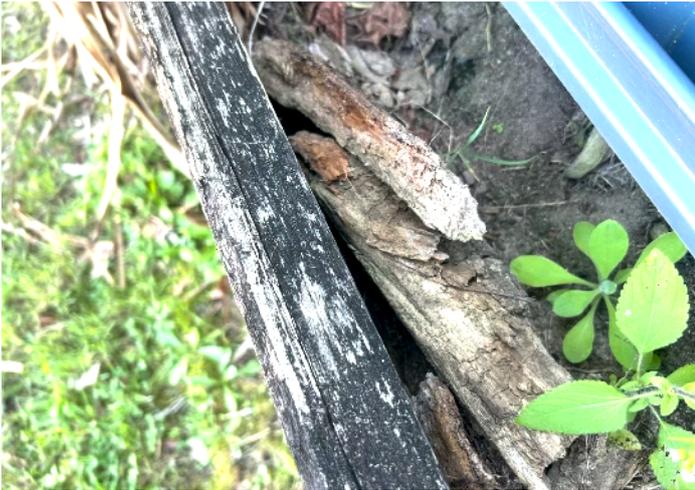
1

Condition of front property timber retaining walls was poor. They are degrading and have loose decaying timbers behind wall. These decaying timbers act as source of food for termite activity and should be removed.

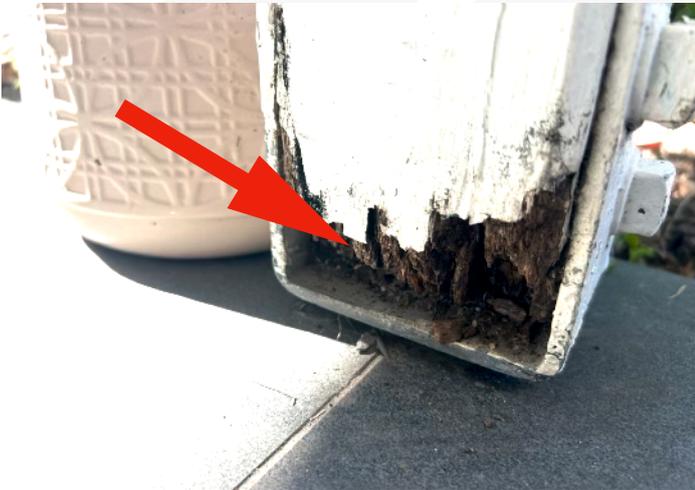
2

Bottom of timber posts at front porch have fungal decay/wet rot and are degrading. Recommend rectification/repairs by licensed builder.

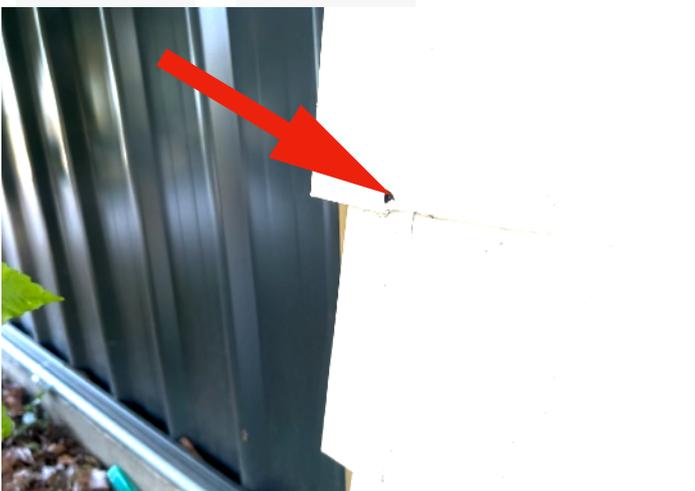
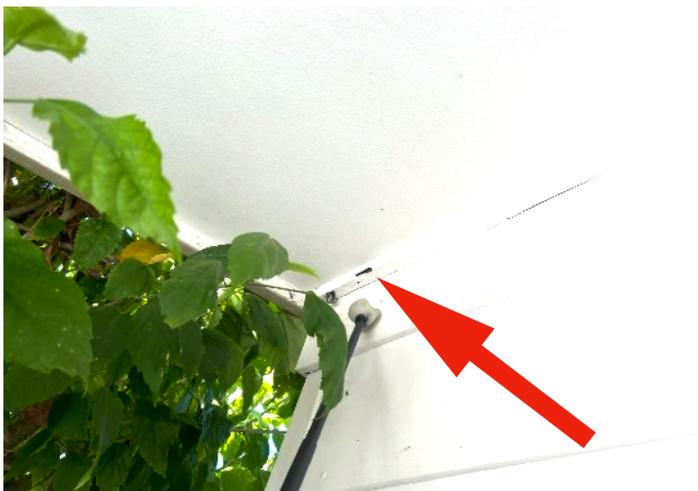
It was evident at the time of inspection that there has been wet rot/termite activity that may have compromised the integrity of the structure that should be invasively investigated to determine the extent of damage

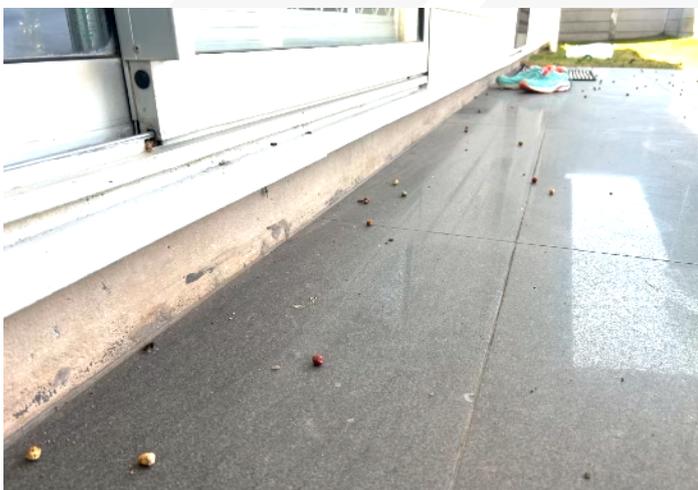
5

The visual inspection zone of slab edge should be kept clear of obstructions to allow for visual inspections regularly

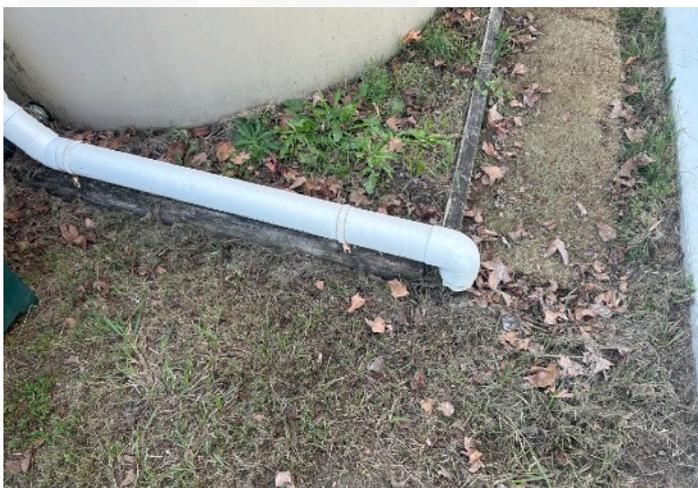
6

Surface drainage to the property needs to be improved to limit the amount of moisture being discharged around the properties footings adding to heightened risk of termite attack

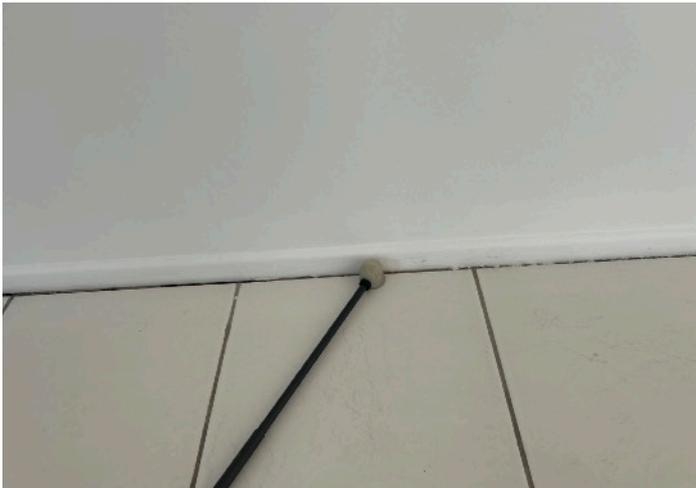
7

It was evident at the time of inspection that there is historic termite damage to skirting boards that requires further investigation and repairs

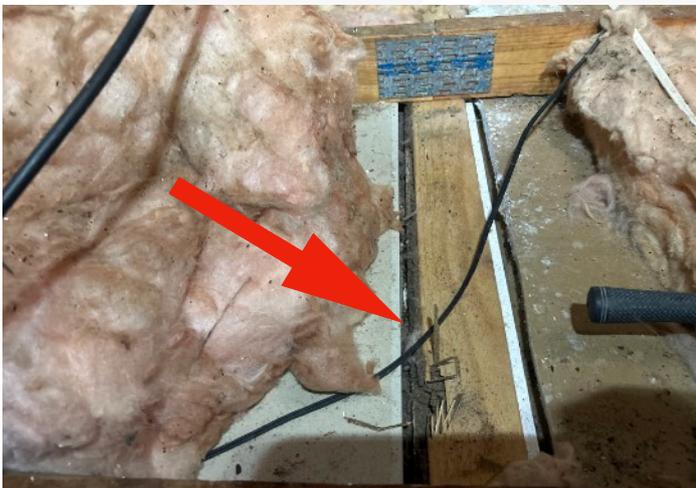
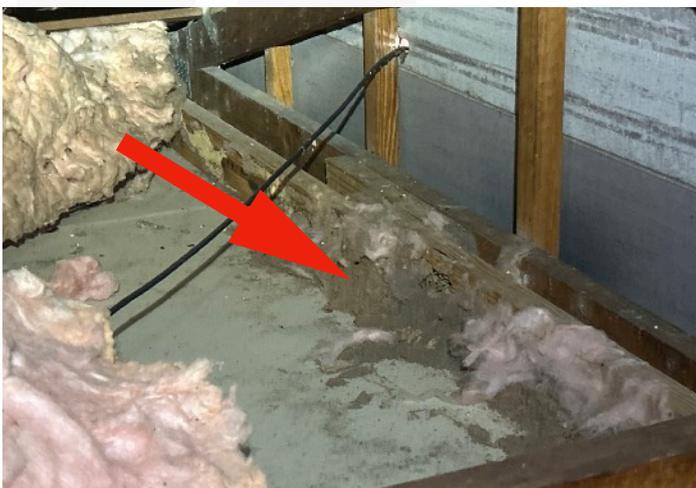
The roof area above the living/ kitchen area had widespread termite workings. At the time of inspection no live termites were found but a more invasive inspection is required to determine the extent of the damage.

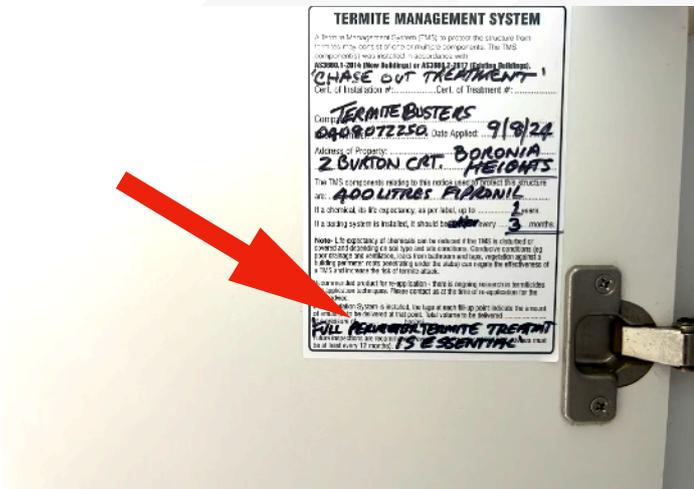
14

Termite notice found in kitchen cabinet stating chase out treatment presumably done for what was the active termite situation in the ceiling on 9/8/24. Also note from Termite Busters “Full Termite Treatment is Essential”. - no record or evidence of chemical barrier was found on site.
