Pre Purchase Building and Pest Inspection

Address:	1 Smith Rd
Day and Time Inspected:	Date: 16/7/2025 12:00pm
Weather and Temperature:	Degrees 22 Humidity 50%

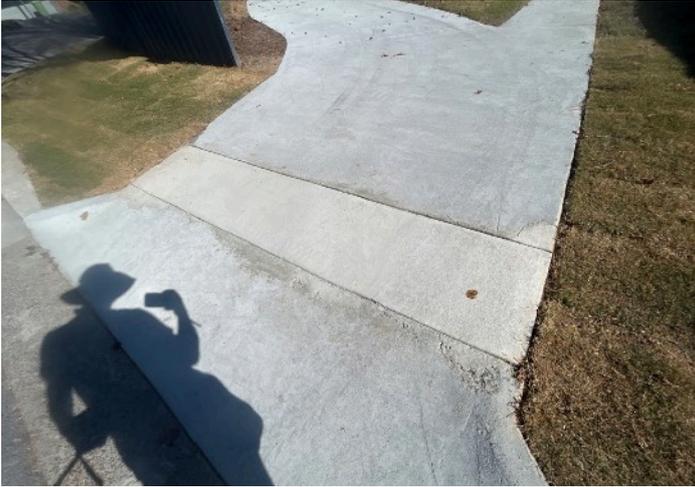
1

Condition of driveway was mostly good/average some hairline cracking was noted see comment on Concrete Cracking – Driveways, Paths and Carports in report below.

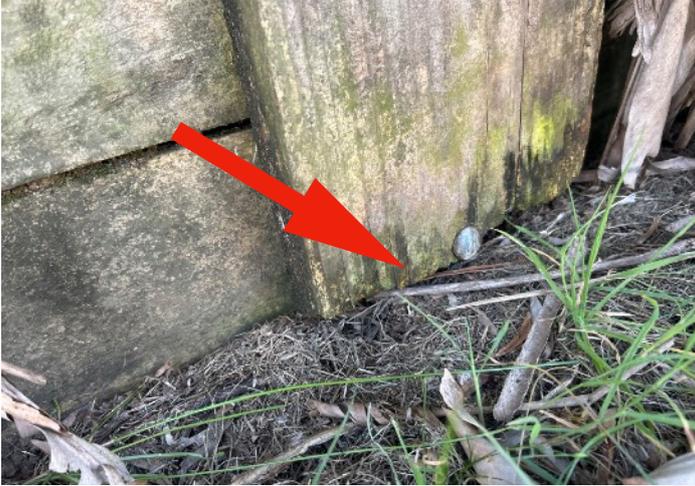
7

Some of the posts to timber retaining wall have almost completely degraded at base of post due to fungal decay and wet rot

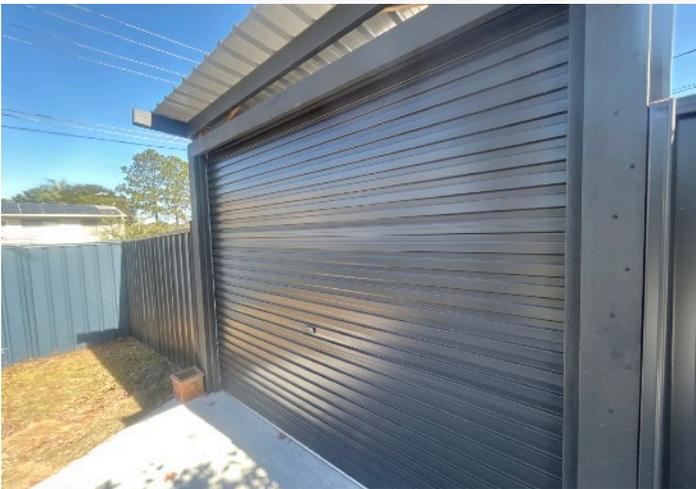
11

Condition of roller door on carport appeared mostly good

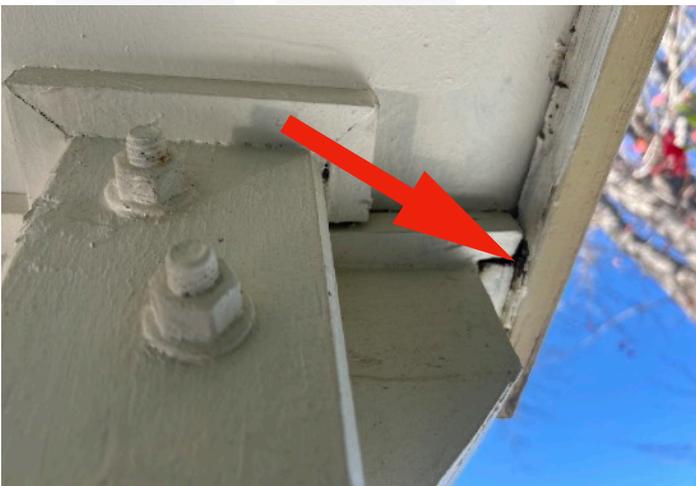
12

There are signs of wet rot and termite activity that requires repairs/ further investigation by a licensed builder

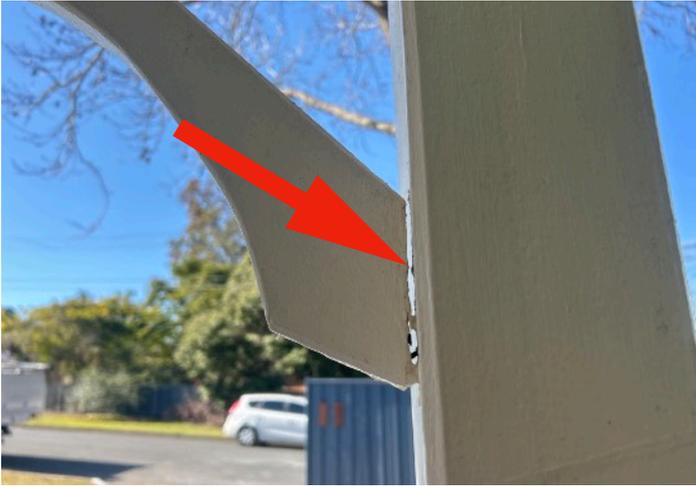
13

Some of the feature trim work to front porch requires additional fixings

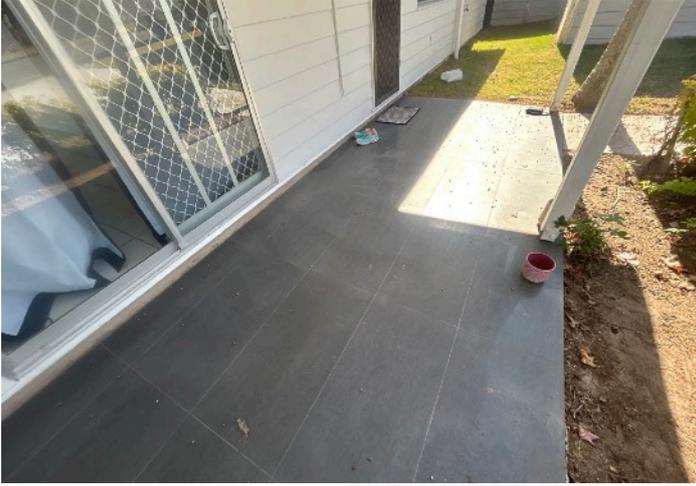
16

Condition of tiles at front porch seemed mostly good

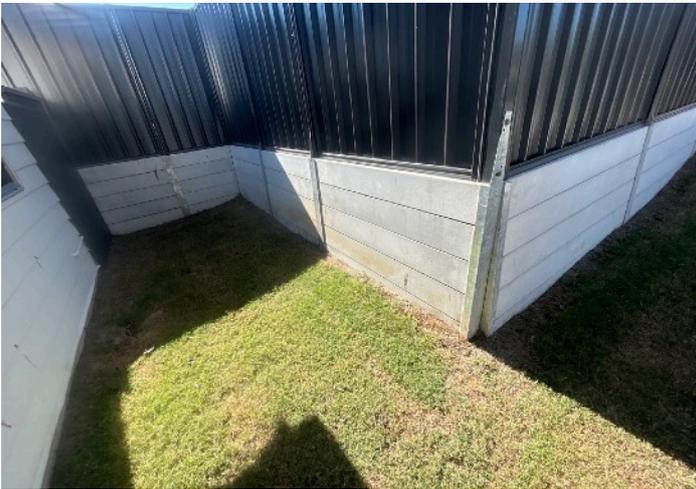
20

Neighbouring boundary retaining wall appeared to be in mostly good condition

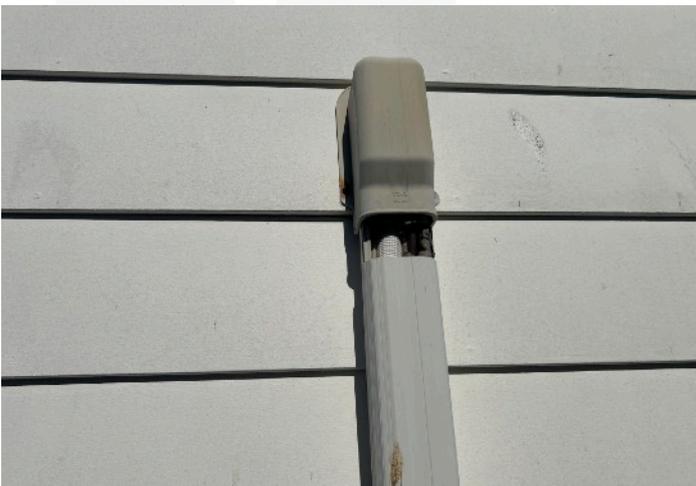
21

Servicing pipes to split Aircon require maintenance/repairs and have degraded

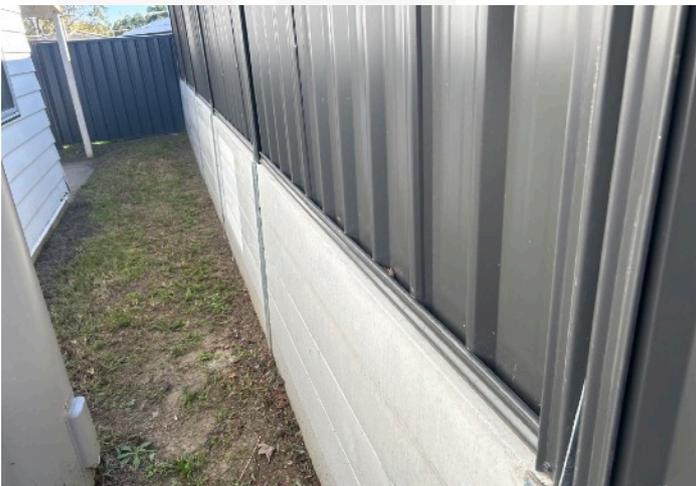
24

Neighbouring boundary retaining wall appeared to be in mostly good condition

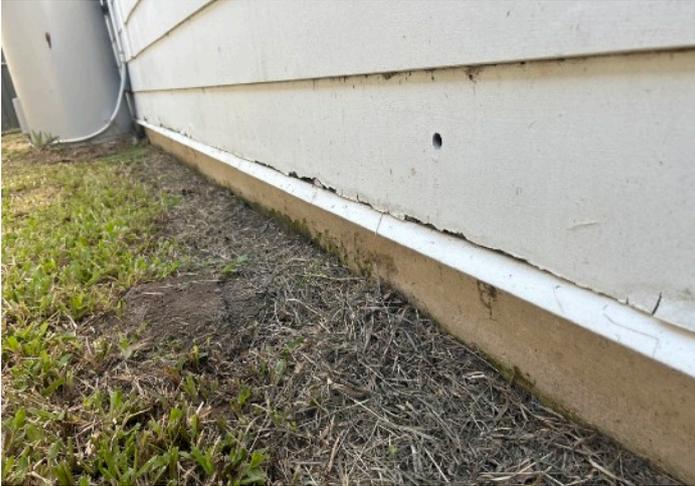
25

It appears there is wet rot/termite damage to the right hand boundary cladding at base requires further investigation - rectification/repairs

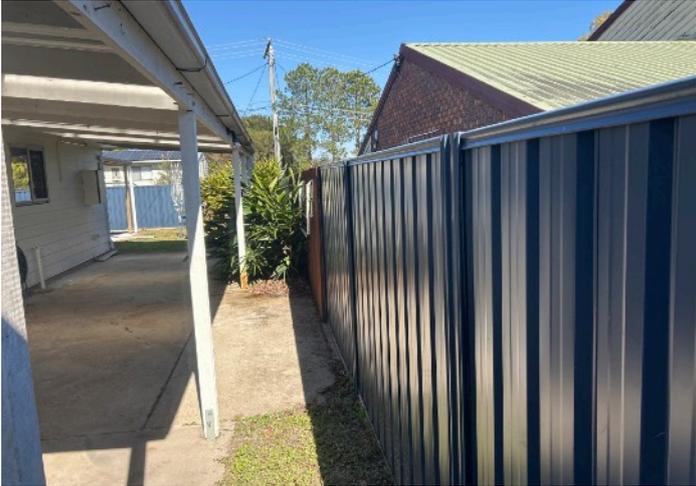
28

Rear fence in average condition

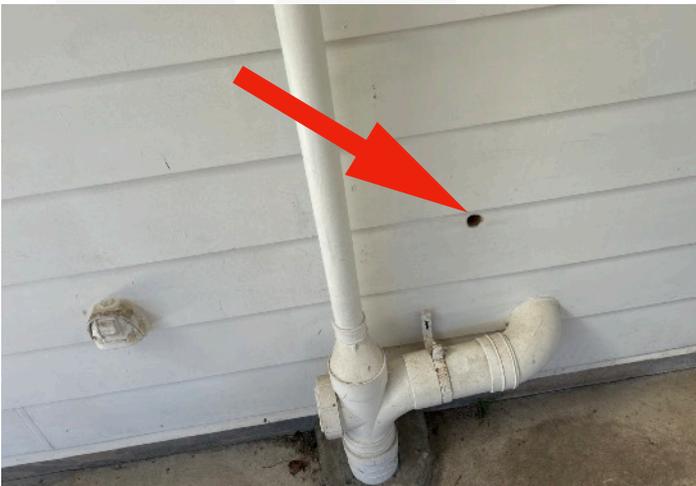
30

Rear walls of the property have holes drilled through cladding which required sealant/ patching

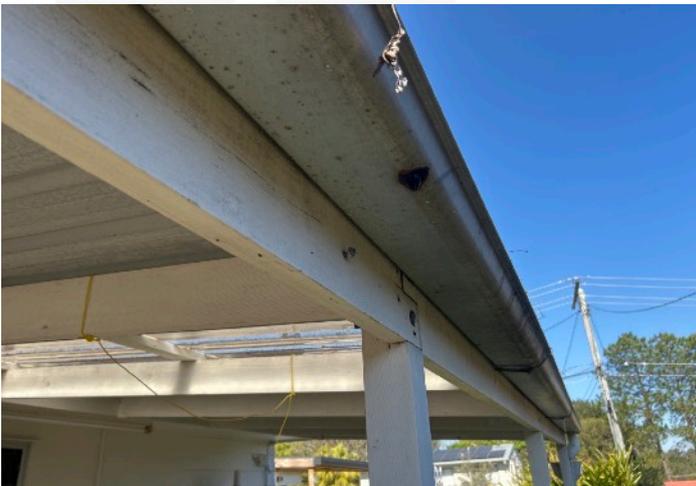
33

Gutter to rear patio roof is leaking and requires repairs. Trade recommendation – roof plumber.

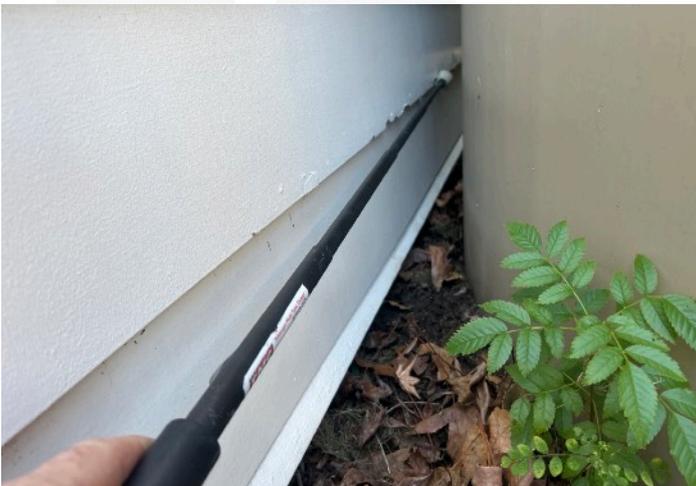
36

Areas of wet rot/termite damage noted to cladding boards behind water tank

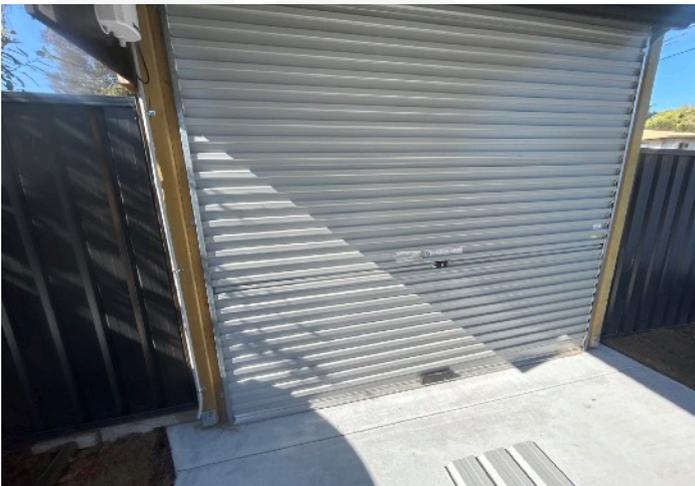
39

At the time of inspection, the roller door was not functioning properly. Recommend having door serviced/inspected.

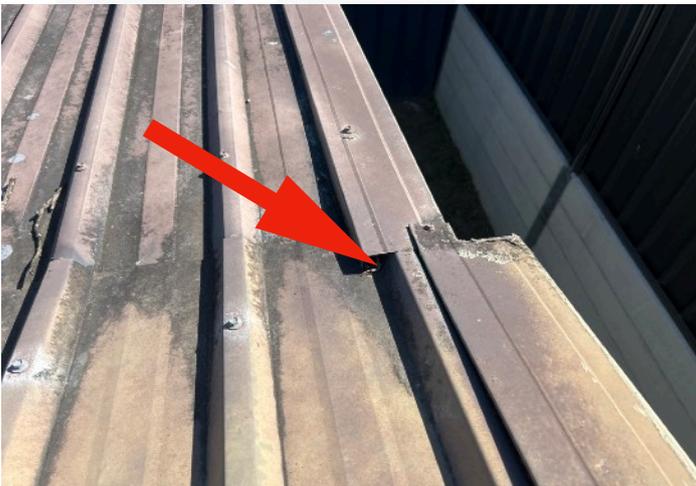
45

Some areas of the roof require additional sealant to be installed to stop potential water ingress into structure below

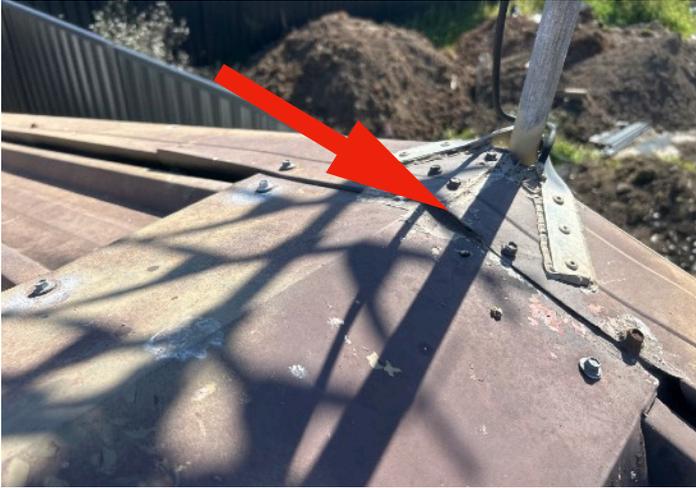
46

Some areas of the roof require additional sealant to be installed to stop potential water ingress into structure below

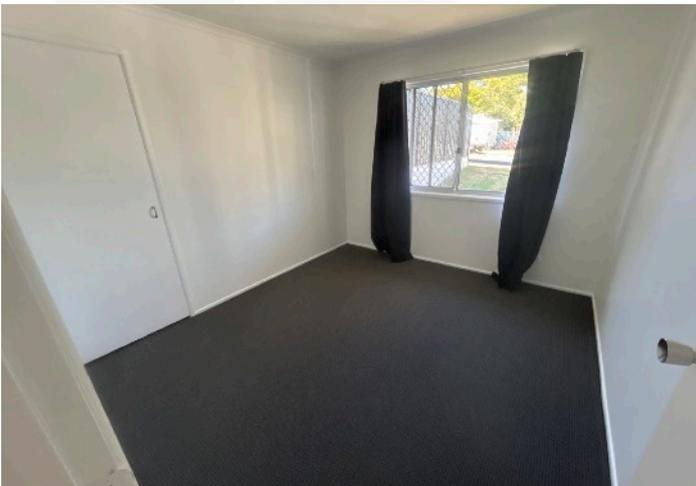
48

Bedroom in mostly average/good condition

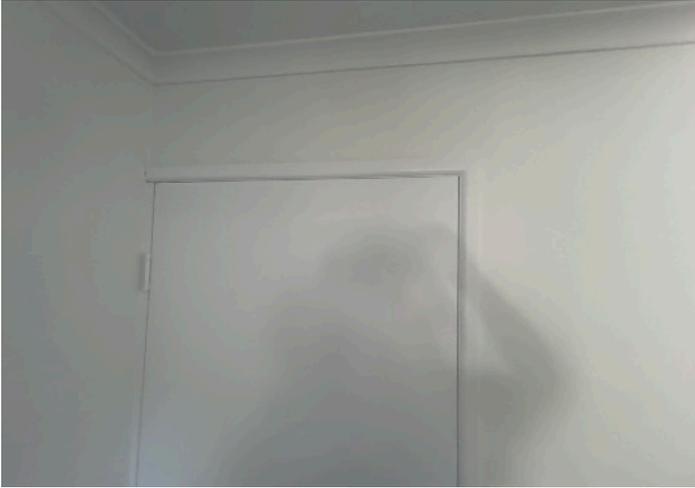
49

Bedroom door requires adjustment.
Trade recommendation – carpenter.

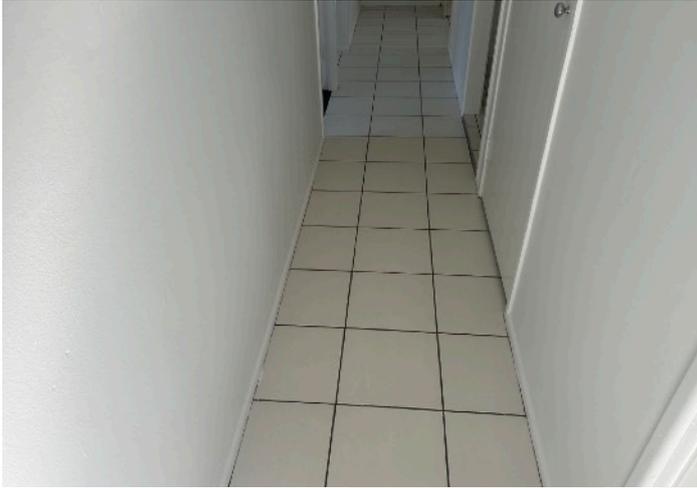
52

Condition of hallway was average

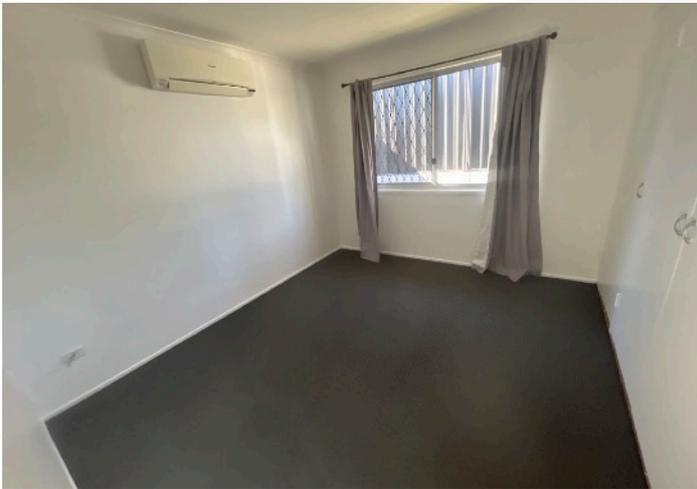
53

Condition of back bedroom was average

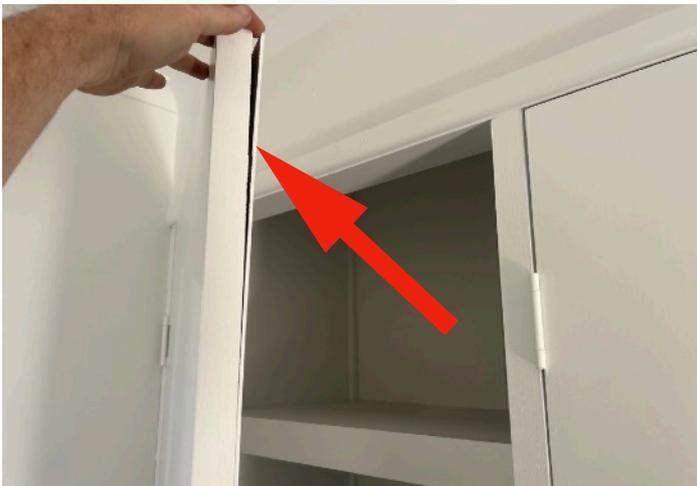
54

Built-in robe to bedroom was in average/poor condition. Door is damaged and requires repairs.

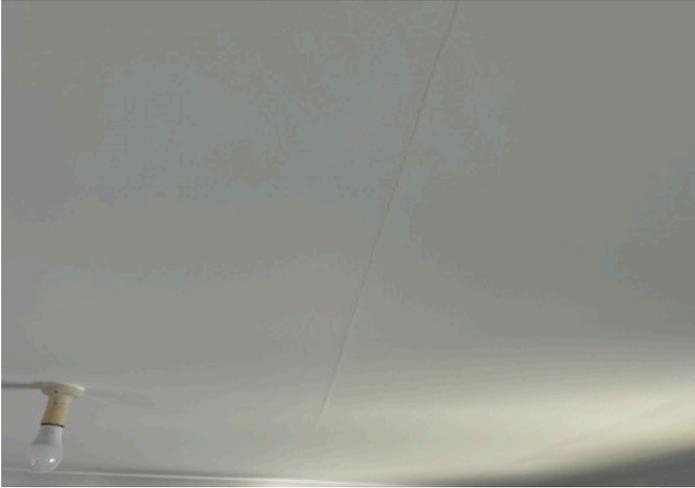
55

Hairline cracking was noted to bedroom ceiling. Trade recommendation – Plasterer.

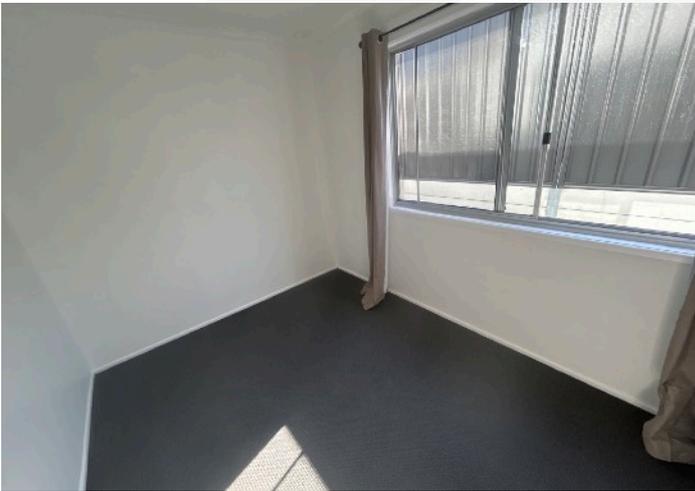
56

Small office/bedroom at rear of property in average condition

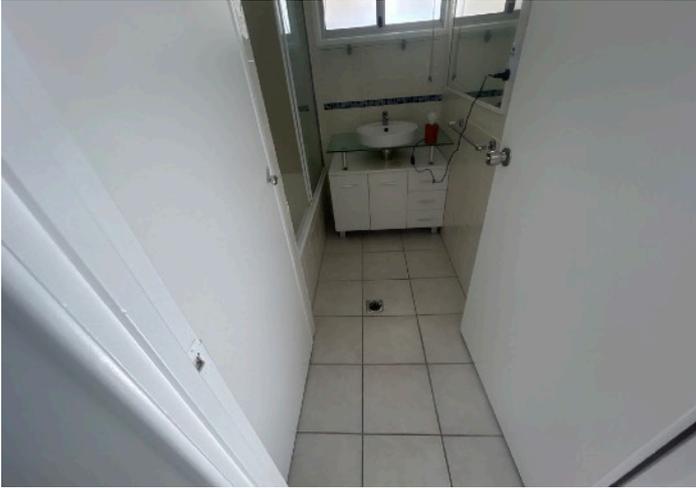
58

Condition of main bathroom was average/poor

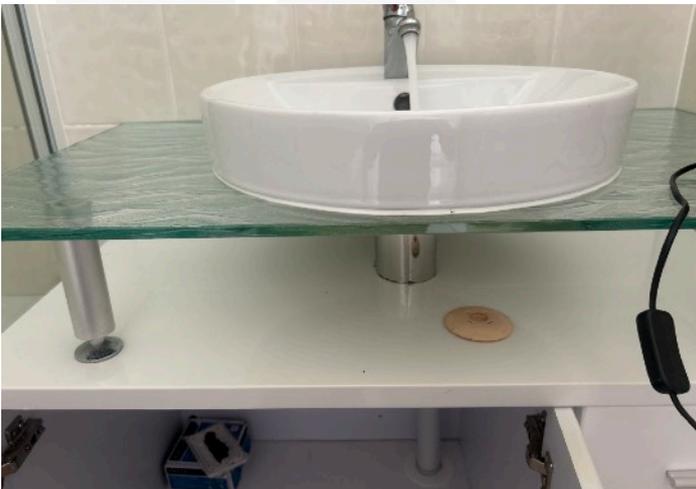
60

Bathroom vanity mixer and sink functioned no external leaks were detected

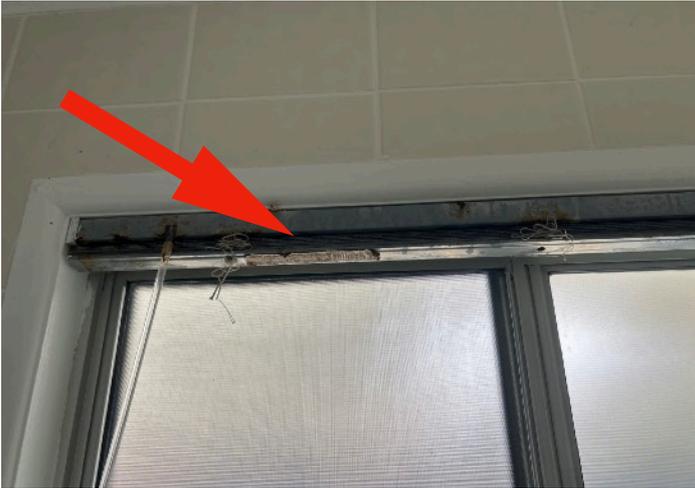
61

Blinds to bathroom window are rusted and degrading recommend replacing

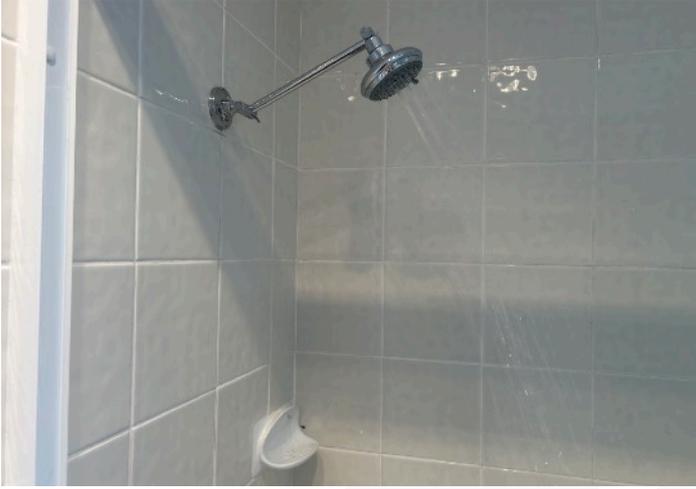
64

Showerhead was functioning at the time of inspection

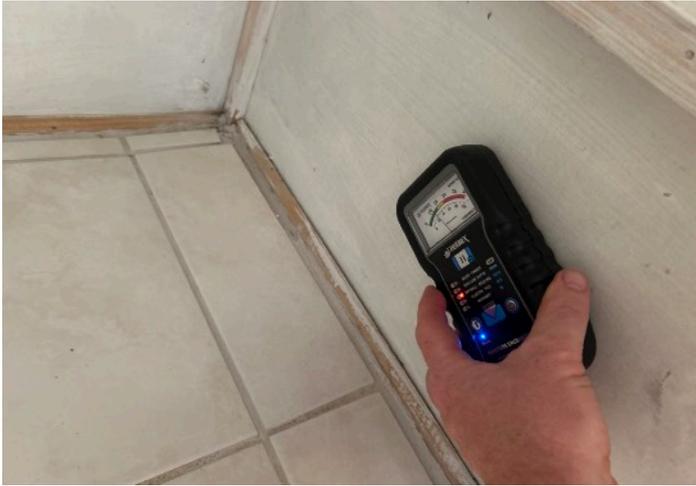
67

Moisture meter readings were taken behind wall surfaces of shower and at the time of inspection no high readings were found. Note showers had been vacant for some time. Meaning of potential leaks may not be picked up

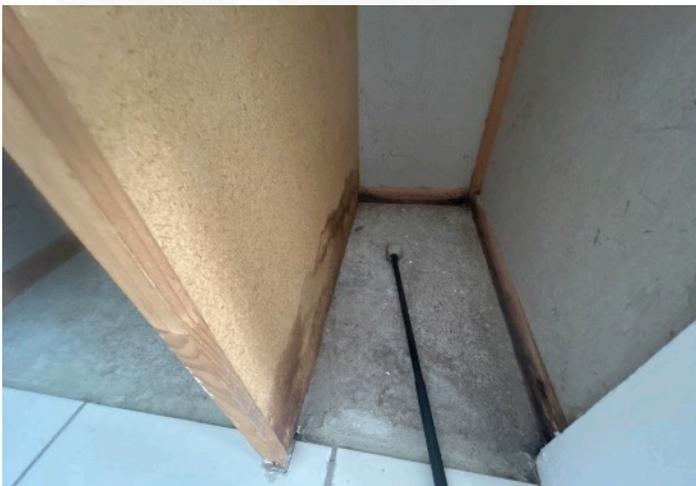
69

It appears there is water damage to cupboard in hallway was dry at the time of inspection but could be coming from bathroom/shower area. Area requires monitoring when bathroom is in use.

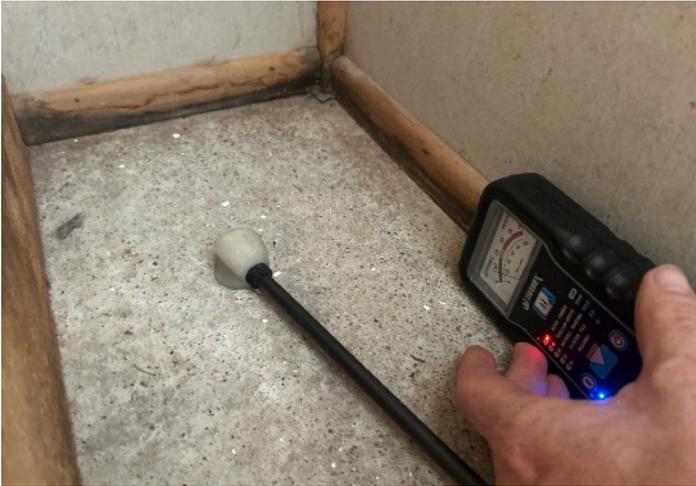
70

It appears there is water damage to cupboard in hallway. Was dry at the time of inspection but could be coming from bathroom/shower area. Area requires monitoring when bathroom is in use.

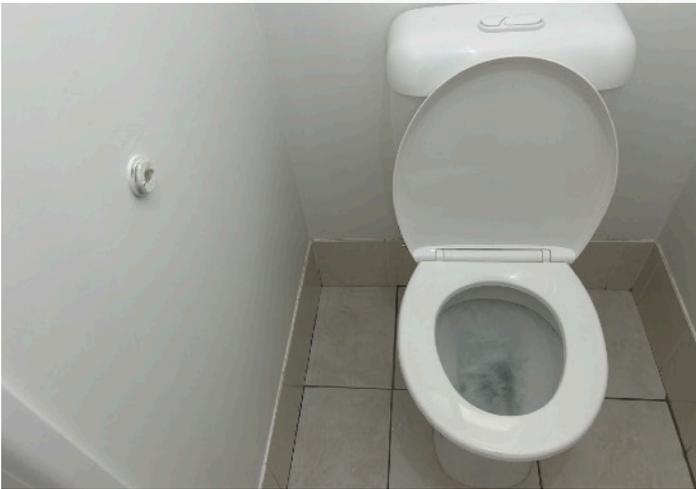
71

Toilet to the property was functioning at the time of inspection

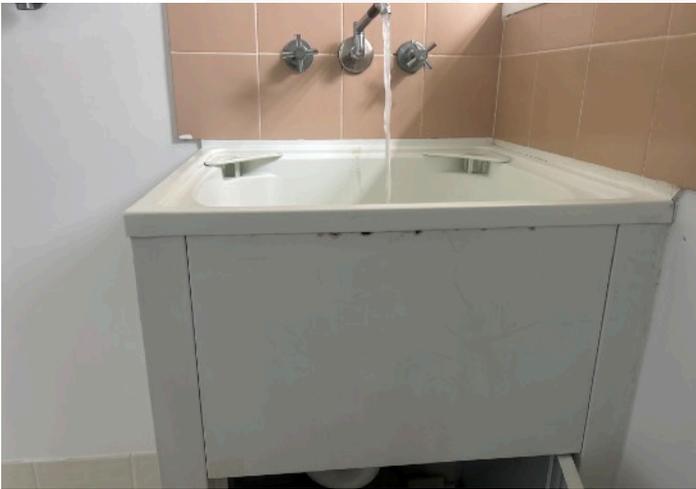
74

Condition of laundry tub was poor taps were functioning at the time of inspection. No external leaks detected.

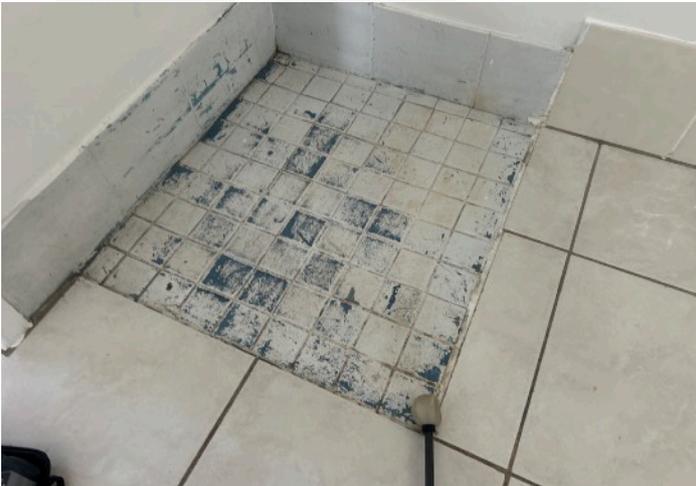
75

Picture shows that tiles have been laid on top of existing old tiles

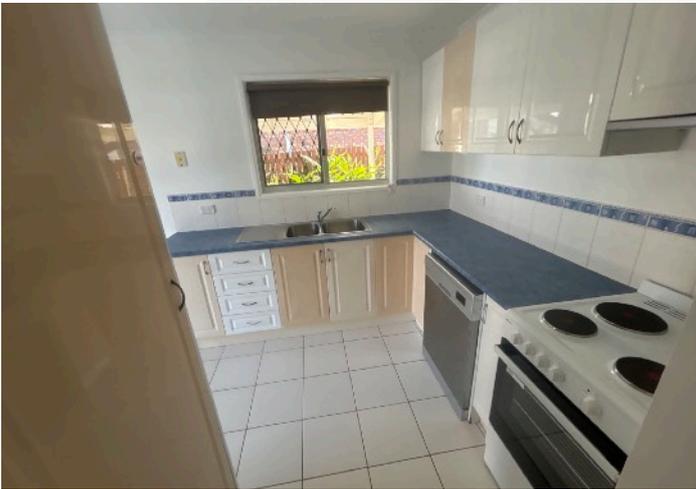
77

Kitchen area was in average condition

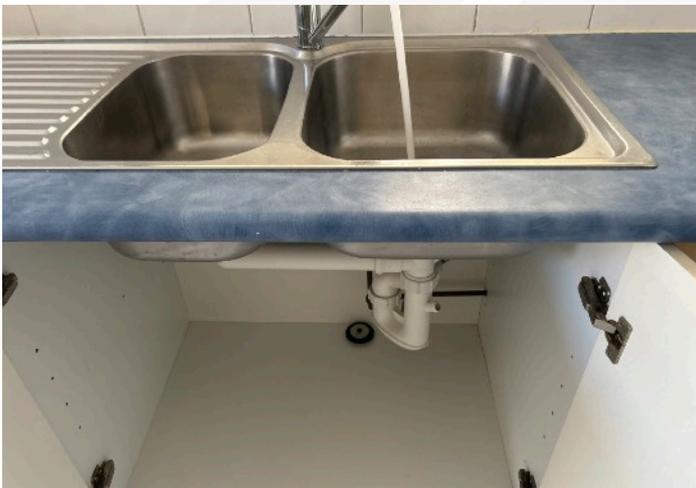
80

Kitchen sink and mixer functioned at the time of inspection. No external leaks were detected.

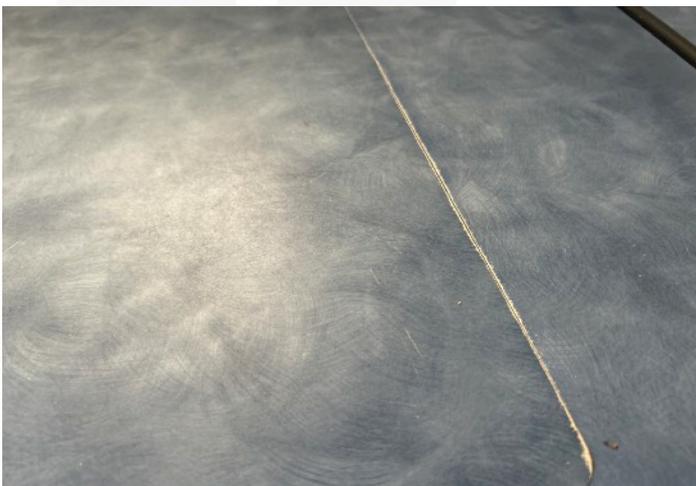
81

Condition of Benchtops was average/poor some areas showed signs of delamination/ water ingress

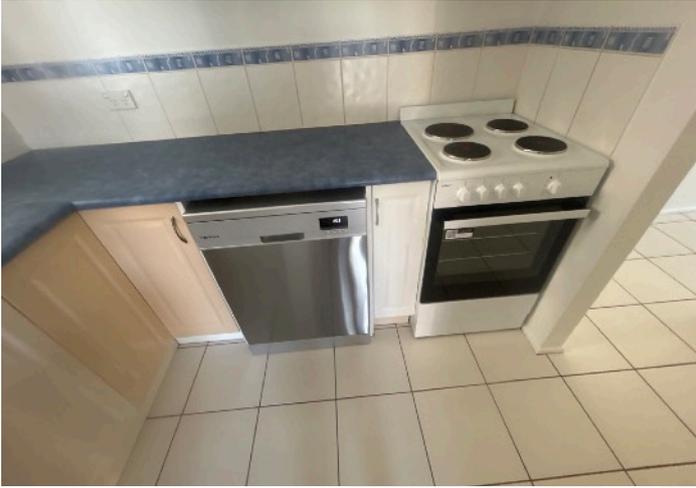
82

Dishwasher and oven appeared to be in mostly good condition – were not tested

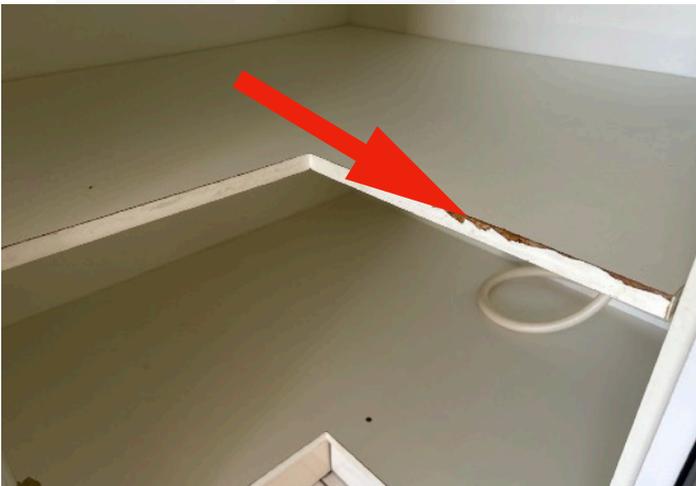
84

damage was noted to some of the cabinetry in the kitchen

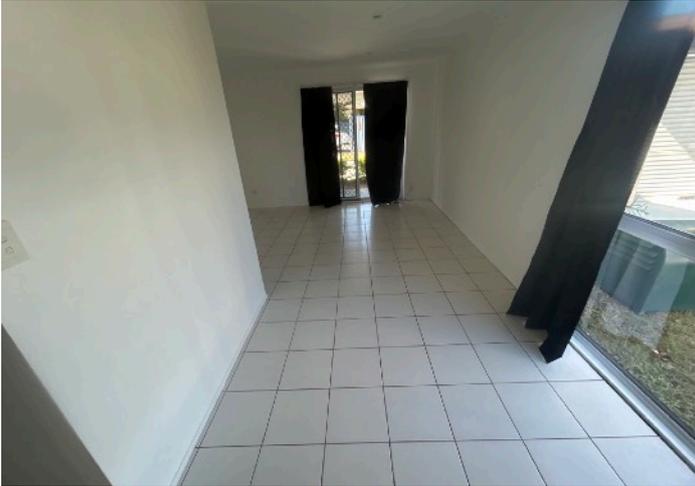
85

Main living/dining area in average condition

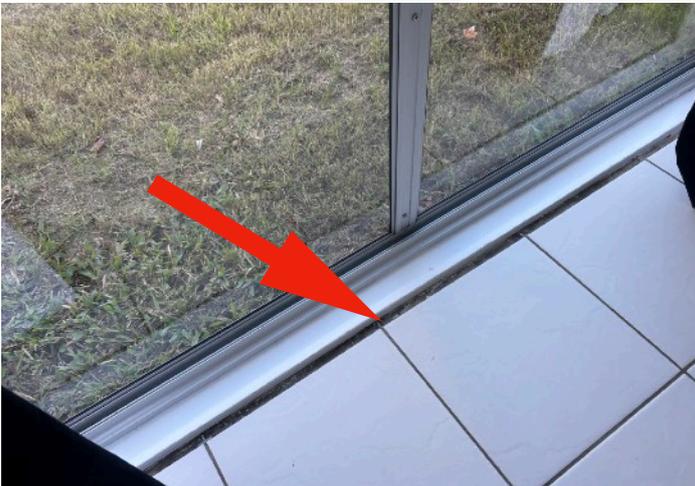
86

Floor tiling is an average condition large gaps are left against wall/ window reveals

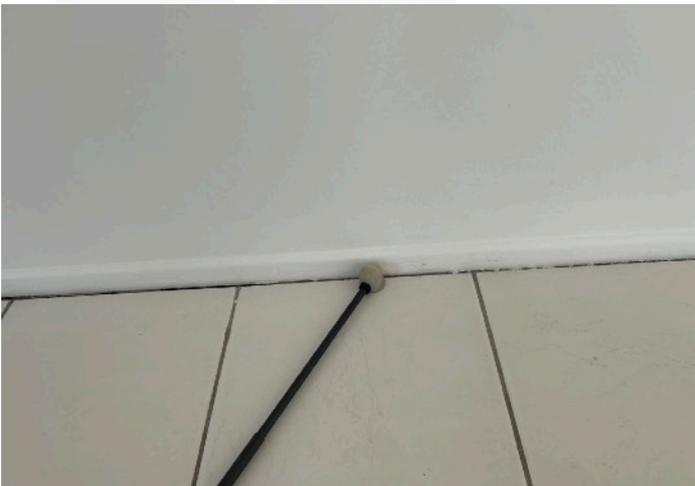
87

Skirting boards to the area have had termite damage. Recommend invasive inspection to determine the extent of the damage.

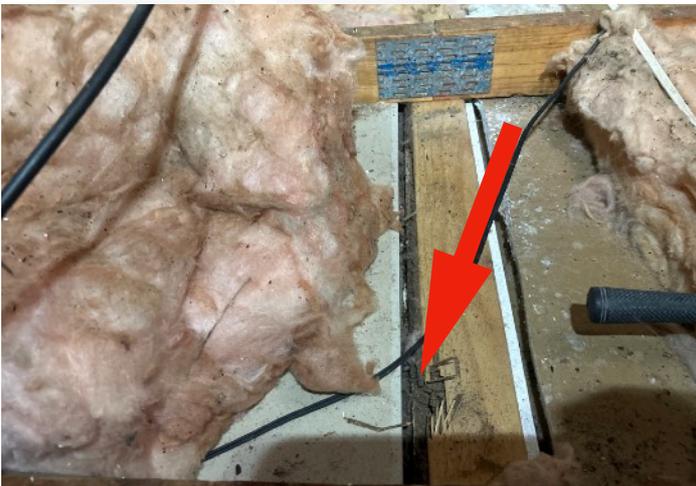
90

Internal roof was inspected and there is historic termite workings

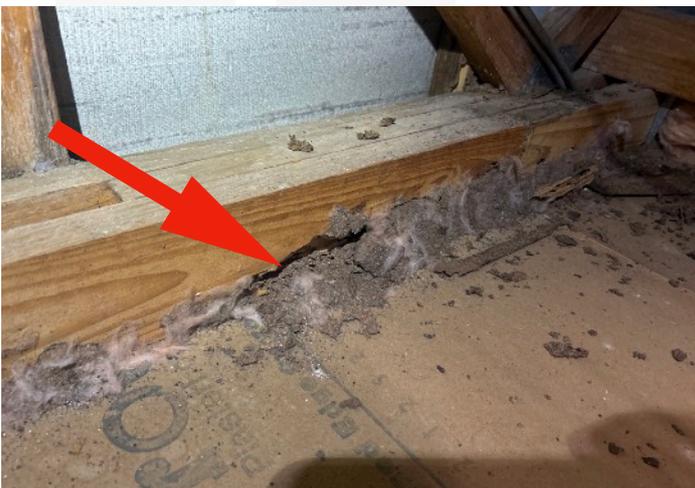
93

Termite workings have damaged the structure of the timber frame. Further invasive investigation is recommended to determine the extent of the damage. Damaged appears to be widespread.

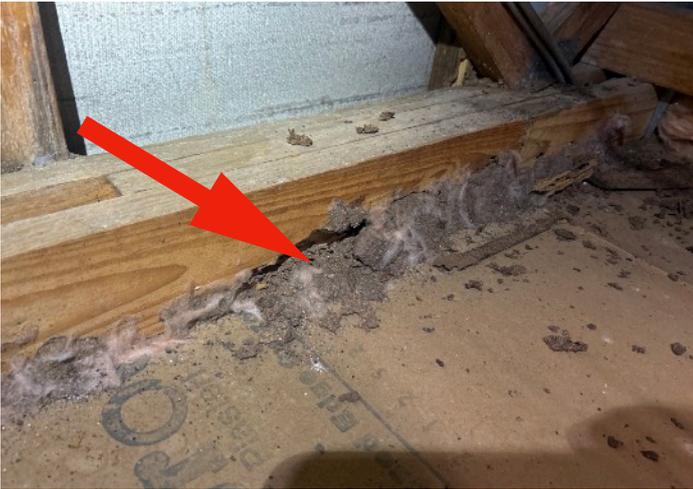
10

The roof area above the living/ kitchen area had widespread termite workings. At the time of inspection no live termites were found but a more invasive inspection is required to determine the extent of the damage.

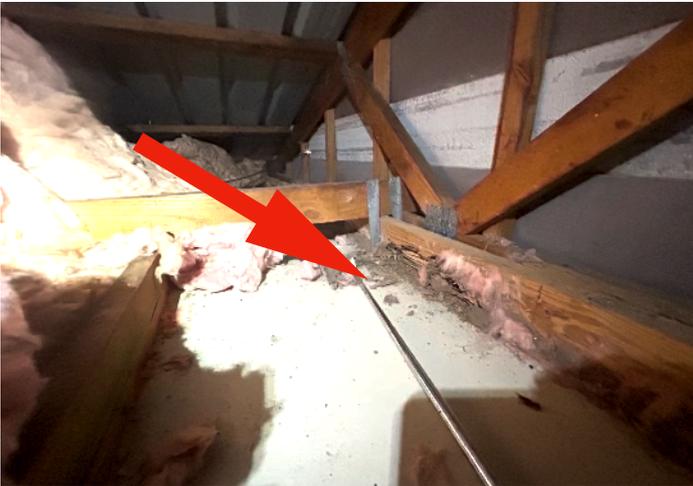
11

The roof area above the living/ kitchen area had widespread termite workings. At the time of inspection no live termites were found but a more invasive inspection is required to determine the extent of the damage.

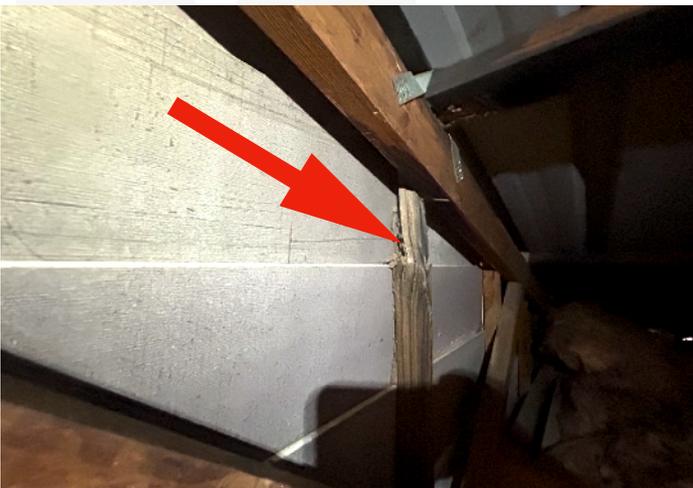
12

The roof area above the living/ kitchen area had widespread termite workings. At the time of inspection no live termites were found but a more invasive inspection is required to determine the extent of the damage.
